General Information

Make	Toyota	Model	Camry
YOM	2019	Odo Meter Reading	35,257
Registration No.	NCL3427	Chassis No.	ME2BF3HK9K4003336
CC	2.5	Transmission	A/T
Fuel Type	Gas	Type of Body	Sedan
Colour	Black

Body / Panel Condition

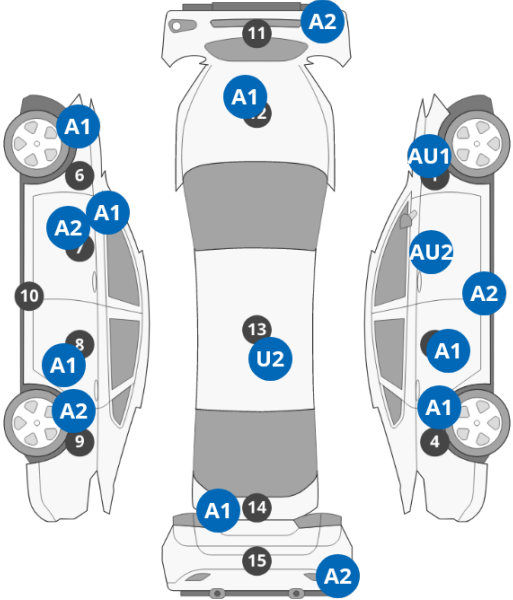
<p>A : Scratch AU : Scratch & Dent B : Modified C : Corrosion G : Stone chip P : Faded S : Rust SC : Rust & Corrosion U : Dent X : Defective Y : Crack, Gap</p>
<p>Remarks Overall Interior - Worn as per age - Yes</p>	<p>Remarks (L) Front Fender - Repair Traces - Yes / (R) Front Fender, Molding - Scratch & Dent - Minimal / (R) Step, In-panel, Side Spoiler - Scratch - Small / (R) Front Door, Molding - Scratch & Dent - Small / (R) Rear Door, Molding - Scratch - Minimal / (R) Rear Fender, Molding - Scratch - Minimal / Rear Bumper, Lamps, Panels - Scratch - Small / Trunk Hood, Rear Gate - Scratch - Minimal / (L) Rear Fender, Molding - Scratch - Small / (L) Rear Door, Molding - Scratch - Minimal / (L) Front Door, Molding - Scratch - Small / (L) Mirror - Scratch - Minimal / (L) Front Fender, Molding - Scratch - Minimal / Front Bumper, Grille, Lamps - Scratch - Small / Bonnet, Headlight - Scratch - Minimal / Roof - Dent - Small</p>
