## General Information

| Make | Toyota | Model | Vios |

## Body / Panel Condition

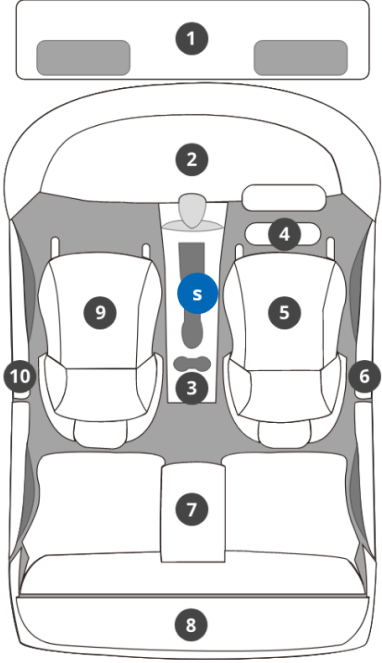
| Interior Evaluation : <b>B</b> | Exterior Evaluation : <b>C</b> |
|---|---|
| <p><b>Remarks</b><br/>Overall Interior - Smell - Yes</p> | <p><b>Remarks</b><br/>Front Bumper, Grille, Lamps - Scratch &amp; Dent - Large / (L) Mirror - Scratch - Small / (L) Front Fender, Molding - Scratch - Minimal / (L) Front Door, Molding - Scratch - Small / (L) Rear Door, Molding - Scratch - Medium / (L) Rear Fender, Molding - Scratch - Minimal / Rear Bumper, Lamps, Panels - Scratch - Small / Trunk Hood, Rear Gate - Scratch - Minimal / (R) Rear Fender, Molding - Scratch &amp; Dent - Small / (R) Rear Door, Molding - Scratch - Minimal / (R) Step, In-panel, Side Spoiler - Scratch &amp; Dent - Small / (R) Front Door, Molding - Scratch - Small / (R) Front Fender, Molding - Scratch - Minimal / Bonnet, Headlight - Scratch - Minimal / Roof - Dent - Small</p> |
