## General Information

| Make | Suzuki | Model | Swift |

## Body / Panel Condition

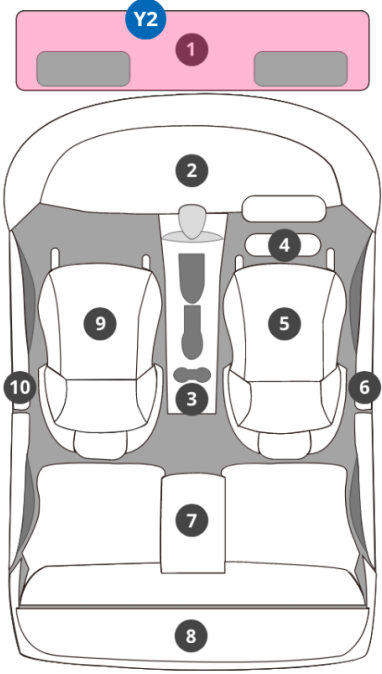
| <b>Interior Evaluation :</b> <span style="color: red; font-weight: bold;">A</span> | <b>Exterior Evaluation :</b> <span style="color: red; font-weight: bold;">B</span> |
| <b>Remarks</b><br>Ceiling - Grime - Small | <b>Remarks</b><br>Trunk Hood, Rear Gate - Scratch - Small / (R) Rear Fender, Molding - Scratch - Small / (R) Rear Door, Molding - Scratch - Small / (R) Front Door, Molding - Scratch - Small / (R) Front Fender, Molding - Scratch - Minimal / Bonnet, Headlight - Scratch - Minimal / (L) Rear Fender, Molding - Scratch - Minimal / (L) Rear Door, Molding - Scratch - Minimal / (L) Front Door, Molding - Scratch - Small / (L) Front Fender, Molding - Scratch - Minimal / Front Bumper, Grille, Lamps - Scratch - Small / Roof - Scratch - Minimal |

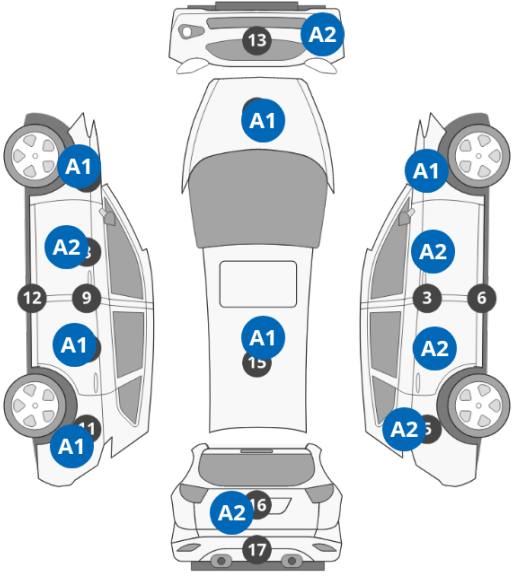
With warranty booklet and LTO plate, Jack and Sparetire, Tools. scratch headlight and tail light.
