General Information

Make	Chevrolet	Model	Spark
YOM	2014	Odo Meter Reading	81,170
Registration No.	ABA5298	Chassis No.	KLMF4811EC442953
CC	1.0	Transmission	M/T
Fuel Type	Gas	Type of Body	Hatchback
Colour	Red

Body / Panel Condition

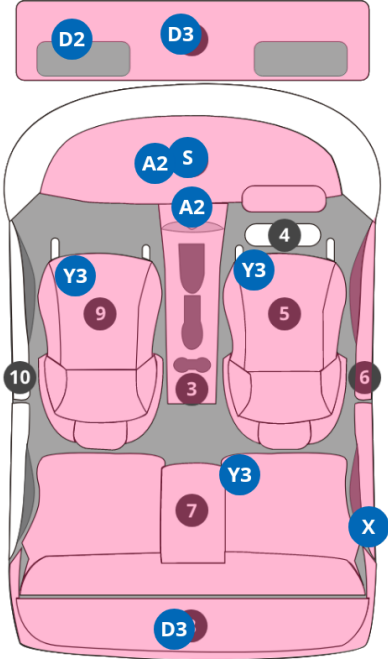
Interior Evaluation : C	Exterior Evaluation : E

<p>a : Cut, Fray d : Loose, Deformed k : Animal Hair s : Smell t : Cigarette Burns x : Defective y : Stain</p>

<p>A : Scratch AU : Scratch & Dent B : Modified C : Corrosion G : Stone chip P : Faded S : Rust SC : Rust & Corrosion U : Dent X : Defective Y : Crack, Gap</p>
<p>Remarks Ceiling - Loose, Deformed - Medium / Sunvisor, Sunglass Holder - Loose, Deformed - Small / Overall Interior - Worn as per age - Yes / Overall Interior - Smell - Yes / (R) Front Seat - Grime - Medium / (L) Front Seat - Grime - Medium / Rear Seat - Grime - Medium / Trunk Room - Loose, Deformed - Medium / Trim Other - Missing - Yes / Console, Switches, Vents - Worn, Scratch, Cut, Crack - Small / Dashboard - Worn, Scratch, Cut, Crack - Small</p>	<p>Remarks (R) Front Fender, Molding - Scratch & Dent - Small / (R) Mirror - Scratch - Small / (R) Front Door, Molding - Scratch & Dent - Medium / (R) Step, In-panel, Side Spoiler - Scratch & Dent - Medium / (R) Rear Door, Molding - Scratch & Dent - Medium / (R) Rear Fender, Molding - Scratch - Small / Rear Bumper, Lamps, Panels - Scratch - Medium / Trunk Hood, Rear Gate - Scratch - Small / (L) Rear Door, Molding - Scratch & Dent - Small / (L) Step, In-panel, Side Spoiler - Scratch & Dent - Medium / (L) Front Fender, Molding - Scratch & Dent - Small / (L) Front Door, Molding - Scratch - Small / Bonnet, Headlight - Scratch & Dent - Minimal / Front Bumper, Grille, Lamps - Scratch - Small / Rear Windshield - Damaged - Small / Roof - Scratch - Minimal</p>
