## General Information

| Make | Toyota | Model | Vios |
| Registration No. | CAW6934 | Chassis No. | PA1B18F34M4164375 |

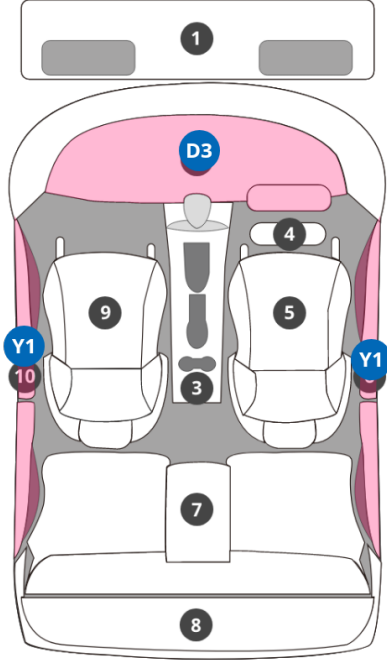
| <b>Remarks</b><br>(R) Front Trim - Grime - Minimal / (L) Front Trim - Grime - Minimal / Instrument Panel - Loose, Deformed - Medium / Overall Interior - Worn as per age - Yes | <b>Remarks</b><br>(R) Front Fender, Molding - Scratch - Minimal / (R) Front Door, Molding - Scratch & Dent - Minimal / (R) Rear Fender, Molding - Scratch & Dent - Minimal / Rear Bumper, Lamps, Panels - Scratch & Dent - Small / Trunk Hood, Rear Gate - Rust, Corrosion - Small / (L) Rear Fender, Molding - Scratch - Minimal / (L) Rear Door, Molding - Scratch - Minimal / (L) Front Door, Molding - Scratch - Minimal / (L) Front Fender, Molding - Scratch - Small / Front Bumper, Grille, Lamps - Scratch - Medium / Bonnet, Headlight - Scratch - Small / Roof - Scratch - Minimal / Overall Exterior - Worn as per age - Yes |
