## General Information

| Make | Toyota | Model | Vios |
| YOM | 2022 | Odo Meter Reading | 94,289 |
| Registration No. | NER8696 | Chassis No. | PA1B18F31N4170815 |

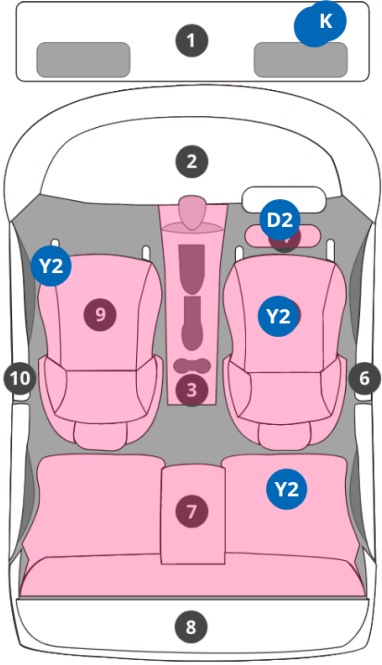
| Interior Evaluation : <b>C</b> | Exterior Evaluation : <b>E</b> |
| <p><b>Remarks</b></p> <p>Overall Interior - Smell - Yes / Overall Interior - Animal Hair - Yes / (R) Front Seat - Grime - Small / Rear Seat - Grime - Small / (L) Front Seat - Grime - Small / (L) Front Floor Mat - Worked - Small / Overall Interior - Worn as per age - Yes / Room Mirror - Missing - Yes</p> | <p><b>Remarks</b></p> <p>Bonnet - Repair Traces - Yes / (L) Front Fender - Repair Traces - Yes / (L) Front Fender, Molding - Repair mark - Yes / Bonnet, Headlight - Repair mark - Yes / Member (Bolted) - Dent - Yes / (L) Front Fender, Molding - Dent - Large / Bonnet, Headlight - Scratch &amp; Dent - Large / Front Bumper, Grille, Lamps - Modified - Medium / (R) Front Door, Molding - Scratch - Small / (R) Front Fender, Molding - Scratch - Small / (R) Rear Door, Molding - Scratch - Small / (R) Rear Fender, Molding - Scratch &amp; Dent - Small / Rear Bumper, Lamps, Panels - Scratch - Small / Trunk Hood, Rear Gate - Scratch - Small / (L) Rear Fender, Molding - Scratch - Small / (L) Step, In-panel, Side Spoiler - Scratch &amp; Dent - Medium / (L) Rear Door, Molding - Scratch - Small / (L) Front Door, Molding - Crack, Gap - Large / (R) Step, In-panel, Side Spoiler - Scratch &amp; Dent - Small / Roof - Scratch &amp; Dent - Small</p> |

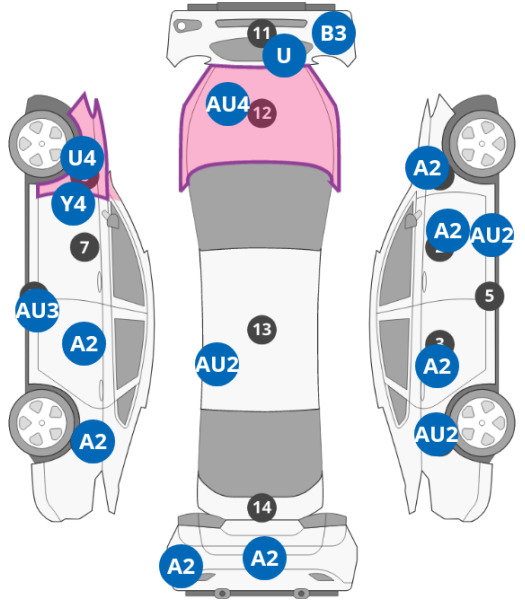
With LTO plate and Spare tire. no warranty booklet and Tools, Crack and scratch headlight and tail light. partially missing front bumper parts, fog light assembly missing, tow hook cover missing, possible flooded, worn tires, adhesive marks on side mirror, vehicle is not moving.
