## General Information

| Make | Toyota | Model | Vios |

## Body / Panel Condition

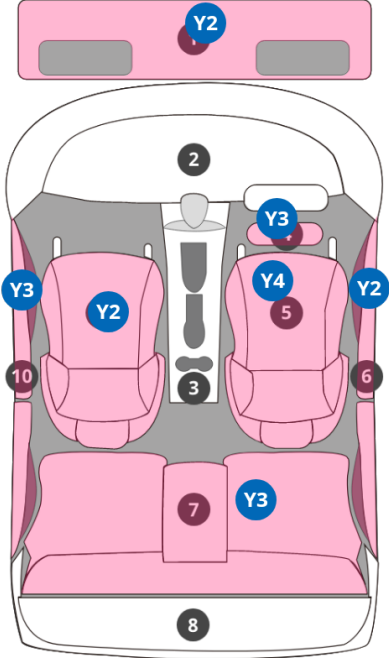
| Interior Evaluation : <span style="color: red; font-weight: bold;">C</span> | Exterior Evaluation : <span style="color: red; font-weight: bold;">E</span> |
| <p><b>Remarks</b></p> <p>Rear Seat - Grime - Medium / (R) Front Seat - Grime - Large / (R) Front Trim - Grime - Small / (L) Front Trim - Grime - Medium / (L) Front Seat - Grime - Small / (L) Front Floor Mat - Grime - Medium / Ceiling - Grime - Small</p> | <p><b>Remarks</b></p> <p>Trunk Hood, Rear Gate - Dent - Medium / Rear Bumper, Lamps, Panels - Scratch &amp; Dent - Medium / (L) Rear Fender, Molding - Scratch - Small / (R) Rear Fender, Molding - Scratch - Small / (R) Rear Door, Molding - Scratch &amp; Dent - Medium / (R) Front Door, Molding - Scratch - Small / (R) Front Fender, Molding - Dent - Medium / Bonnet, Headlight - Scratch &amp; Dent - Medium / Front Bumper, Grille, Lamps - Scratch - Medium / (L) Front Fender, Molding - Scratch - Small / (L) Step, In-panel, Side Spoiler - Scratch &amp; Dent - Small / (L) Front Door, Molding - Scratch - Small / (L) Rear Door, Molding - Scratch &amp; Dent - Small / Roof - Scratch - Minimal</p> |
