## General Information

| Make | Toyota | Model | Vios |
| YOM | 2023 | Odo Meter Reading | 75,362 |
| Registration No. | NIL3175 | Chassis No. | PA1B18F33P4205471 |

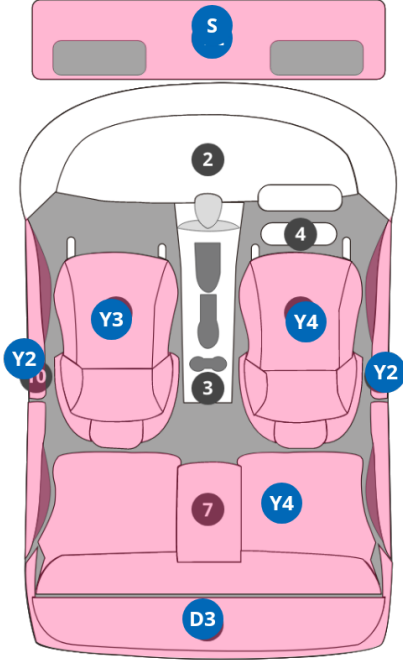
| Interior Evaluation : <b>C</b> | Exterior Evaluation : <b>E</b> |
|---|---|
| <p><b>Remarks</b></p> <p>Trunk Room - Loose, Deformed - Medium / Rear Seat - Grime - Large / (R) Front Seat - Grime - Large / (R) Front Trim - Grime - Small / Ceiling - Grime - Small / (L) Front Seat - Grime - Medium / (L) Front Trim - Grime - Small / Overall Interior - Smell - Yes</p> | <p><b>Remarks</b></p> <p>(R) Front Fender, Molding - Scratch - Minimal / (R) Front Door, Molding - Scratch - Medium / (R) Rear Door, Molding - Scratch - Medium / (R) Rear Fender, Molding - Scratch - Small / Rear Bumper, Lamps, Panels - Scratch - Medium / Trunk Hood, Rear Gate - Scratch &amp; Dent - Minimal / (L) Rear Fender, Molding - Scratch &amp; Dent - Large / (L) Rear Door, Molding - Scratch &amp; Dent - Large / (L) Step, In-panel, Side Spoiler - Scratch - Small / (L) Front Door, Molding - Scratch - Small / (L) Mirror - Scratch - Small / (L) Front Fender, Molding - Scratch - Minimal / Front Bumper, Grille, Lamps - Scratch - Large / Bonnet, Headlight - Scratch - Minimal / Roof - Scratch - Minimal</p> |
