## General Information

| Make | MG | Model | ZS |

## Body / Panel Condition

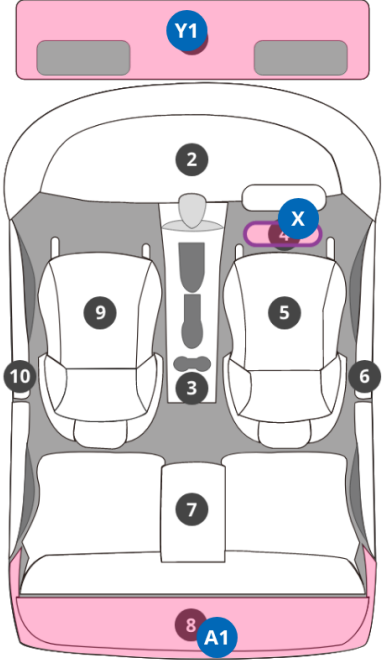
| <p><b>a</b> : Cut, Fray <b>d</b> : Loose, Deformed <b>k</b> : Animal Hair <b>s</b> : Smell <b>t</b> : Cigarette Burns <b>x</b> : Defective <b>y</b> : Stain</p> | <p><b>A</b> : Scratch <b>AU</b> : Scratch &amp; Dent <b>B</b> : Modified <b>C</b> : Corrosion <b>G</b> : Stone chip <b>P</b> : Faded <b>S</b> : Rust <b>SC</b> : Rust &amp; Corrosion <b>U</b> : Dent <b>X</b> : Defective <b>Y</b> : Crack, Gap</p> |
| <b>Remarks</b><br>Mat Other - Missing - Yes / Trunk Room - Worn, Scratch, Cut, Crack - Minimal / Ceiling - Grime - Minimal | <b>Remarks</b><br>(L) Front Door - Repair Traces - Yes / (L) Rear Door - Repair Traces - Yes / Bonnet, Headlight - Dent - Small / (L) Front Fender, Molding - Scratch - Small / (L) Front Door, Molding - Scratch - Medium / (L) Front Door, Molding - Repair mark - Yes / (L) Rear Door, Molding - Repair mark - Yes / Rear Bumper, Lamps, Panels - Scratch - Medium / Trunk Hood, Rear Gate - Scratch & Dent - Small / (R) Mirror - Scratch - Minimal / Front Bumper, Grille, Lamps - Scratch - Small / (L) Rear Fender, Molding - Scratch - Minimal / (R) Rear Door, Molding - Scratch - Minimal |
