## General Information

| Make | Toyota | Model | Vios |
| YOM | 2024 | Odo Meter Reading | 11,673 |

## Body / Panel Condition

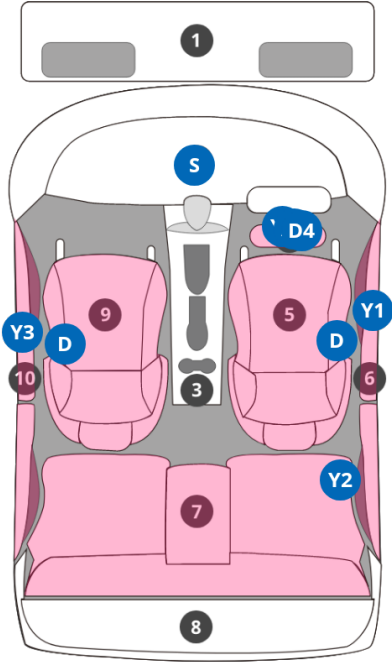
| Interior Evaluation : <span>C</span> | Exterior Evaluation : <span>C</span> |
|---|---|
| <b>Remarks</b><br>Overall Interior - Smell - Yes / Mat Other - Grime - Small / Rear Seat - Grime - Small / (R) Front Trim - Grime - Minimal / (L) Front Seat - Worn - Yes / (R) Front Seat - Worn - Yes / (L) Front Trim - Grime - Medium / (L) Front Floor Mat - Cut, Crack - Small / (L) Front Floor Mat - Worked - Large | <b>Remarks</b><br>(R) Front Fender, Molding - Scratch - Minimal / (R) Rear Door, Molding - Scratch - Small / (R) Front Door, Molding - Scratch - Minimal / (R) Step, In-panel, Side Spoiler - Scratch & Dent - Large / (R) Rear Fender, Molding - Scratch - Minimal / Trunk Hood, Rear Gate - Scratch - Minimal / Rear Bumper, Lamps, Panels - Scratch - Small / (L) Rear Fender, Molding - Scratch - Minimal / (L) Front Door, Molding - Scratch - Small / (L) Rear Door, Molding - Scratch - Medium / Member (Bolted) - Dent - Yes / Front Bumper, Grille, Lamps - Scratch & Dent - Small / Bonnet, Headlight - Scratch - Minimal / Roof - Scratch - Minimal / (L) Front Fender, Molding - Dent - Small |

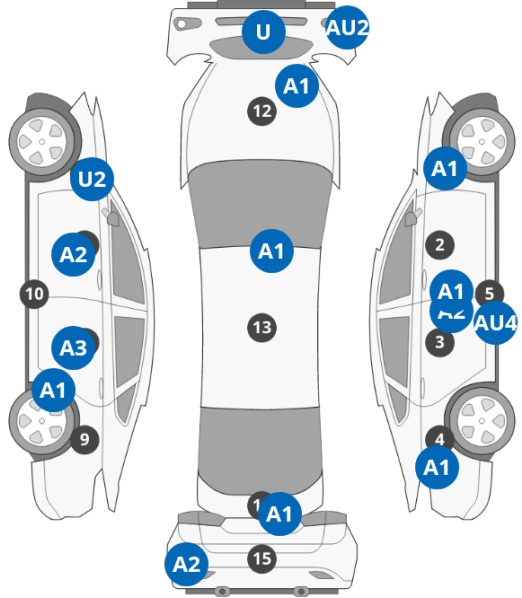
no warranty booklet, with jack, incomplete tools, with spare tire, with LTO plate, scratches on tail, possible flooding, worn tires
