## General Information

| Make | Mitsubishi | Model | Strada |
| YOM | 2019 | Odo Meter Reading | 50,874 |
| Registration No. | DAL8043 | Chassis No. | MMBJLKK10KH031983 |

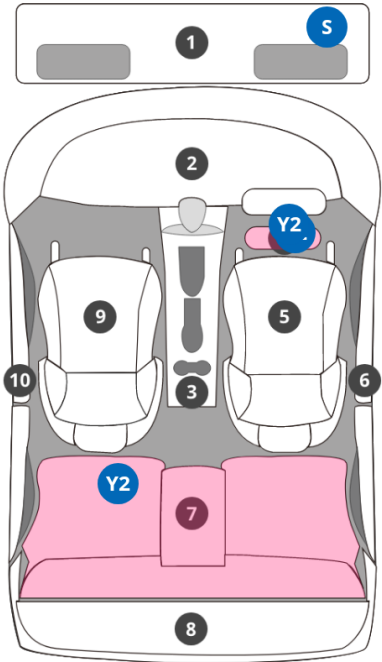
| Interior Evaluation : <span style="color: red; font-weight: bold;">C</span> | Exterior Evaluation : <span style="color: red; font-weight: bold;">C</span> |
|---|---|
| <b>Remarks</b><br>(L) Front Floor Mat - Grime - Small / (R) Front Floor Mat - Grime - Small / Rear Seat - Grime - Small / Overall Interior - Worn as per age - Yes / Overall Interior - Smell - Yes | <b>Remarks</b><br>(R) Step, In-panel, Side Spoiler - Scratch - Small / (R) Front Door, Molding - Scratch - Small / (R) Rear Door, Molding - Scratch & Dent - Small / (R) Side Gate - Scratch - Small / Rear Bumper, Lamps, Panels - Scratch - Small / Rear Gate - Scratch - Minimal / (L) Side Gate - Scratch - Small / (L) Step, In-panel, Side Spoiler - Scratch - Small / (L) Rear Door, Molding - Scratch & Dent - Minimal / (L) Front Door, Molding - Scratch - Small / (L) Rear Wheel, Cover - Scratch, Corrosion - Small / (L) Front Wheel, Cover - Scratch, Corrosion - Small / (R) Front Wheel, Cover - Scratch, Corrosion - Small / (R) Rear Wheel, Cover - Scratch, Corrosion - Small / Roof - Scratch & Dent - Medium / Bonnet, Headlight - Scratch - Small / Front Bumper, Grille, Lamps - Scratch - Small |

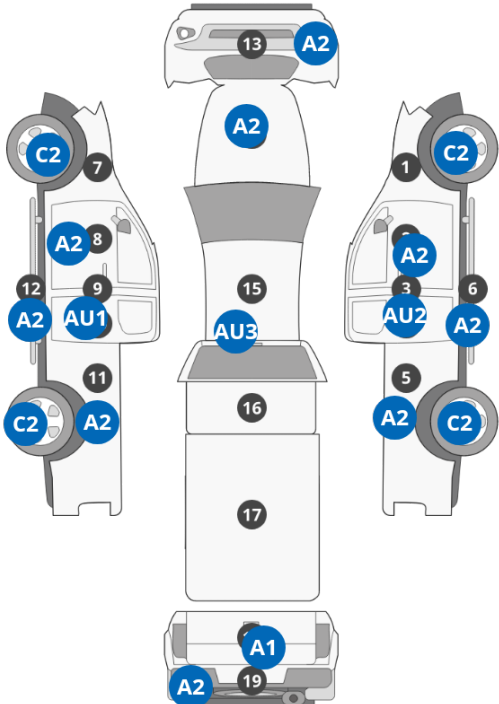
| Inspector Notes |
|---|
| With LTO plate and Sparetire, Jack, Incomplete Tools. no warranty booklet and worn aftermarket wheels. scratch headlight and tail light. I |
