General Information

Make	Honda	Model	City
YOM	2017	Odo Meter Reading	80,362
Registration No.	NDD7324	Chassis No.	PADGM6630HV310218
CC	1.5	Transmission	A/T
Fuel Type	Gas	Type of Body	Sedan
Colour	Brown

Body / Panel Condition

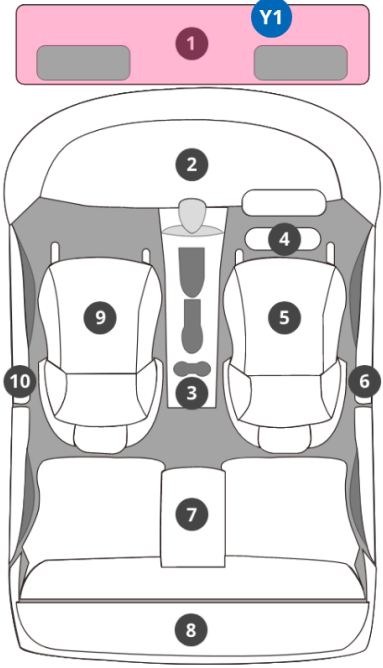
Interior Evaluation : C	Exterior Evaluation : E

<p>a : Cut, Fray d : Loose, Deformed k : Animal Hair s : Smell t : Cigarette Burns x : Defective y : Stain</p>

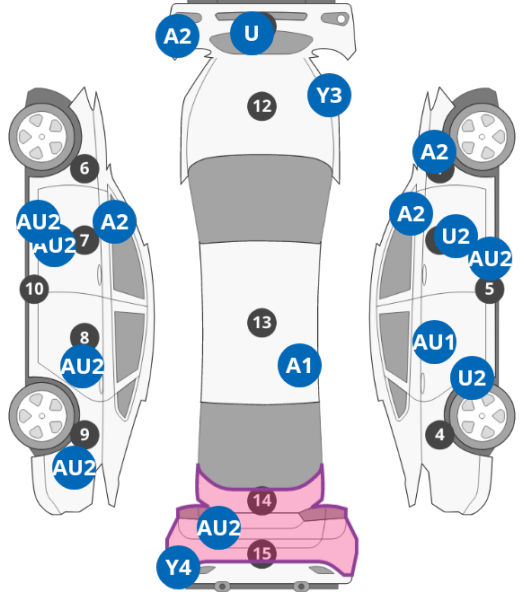
<p>A : Scratch AU : Scratch & Dent B : Modified C : Corrosion G : Stone chip P : Faded S : Rust SC : Rust & Corrosion U : Dent X : Defective Y : Crack, Gap</p>
<p>Remarks Overall Interior - Worn as per age - Yes / Ceiling - Grime - Minimal</p>	<p>Remarks (R) Front Fender - Repair Traces - Yes / Bonnet - Repair Traces - Yes / (L) Front Fender - Repair Traces - Yes / (R) Front Fender, Molding - Scratch - Small / (R) Mirror - Scratch - Small / (R) Front Door, Molding - Dent - Small / (R) Step, In-panel, Side Spoiler - Scratch & Dent - Small / (R) Rear Door, Molding - Scratch & Dent - Minimal / (R) Rear Fender, Molding - Dent - Small / Rear Bumper, Lamps, Panels - Crack, Gap - Large / Trunk Hood, Rear Gate - Repair mark - Yes / Trunk Hood, Rear Gate - Scratch & Dent - Small / (L) Rear Fender, Molding - Scratch & Dent - Small / (L) Front Door, Molding - Scratch & Dent - Small / (L) Rear Door, Molding - Scratch & Dent - Small / (L) Step, In-panel, Side Spoiler - Scratch & Dent - Small / (L) Mirror - Scratch - Small / Member (Bolted) - Dent - Yes / Front Bumper, Grille, Lamps - Scratch - Small / Bonnet, Headlight - Crack, Gap - Medium / Roof - Scratch - Minimal</p>
