General Information

Make	Mitsubishi	Model	Mirage
YOM	2018	Odo Meter Reading	63,845
Registration No.	NBS8220	Chassis No.	PAEA13TJJA006916
CC	1.2	Transmission	A/T
Fuel Type	Gas	Type of Body	Sedan
Colour	Black

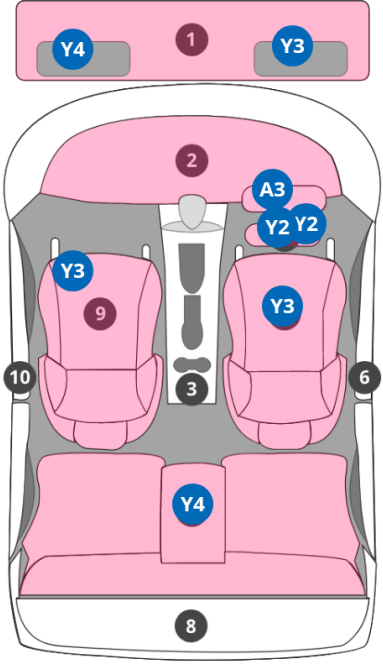
Interior Evaluation : D	Exterior Evaluation : E

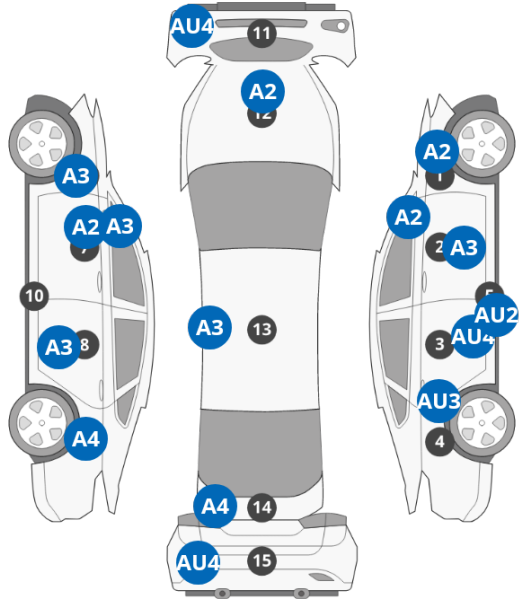
<p>A : Scratch AU : Scratch & Dent B : Modified C : Corrosion G : Stone chip P : Faded S : Rust SC : Rust & Corrosion U : Dent X : Defective Y : Crack, Gap</p>
<p>Remarks (R) Front Floor Mat - Grime - Small / (R) Front Seat - Grime - Medium / Rear Seat - Grime - Large / Mat Other - Grime - Small / (L) Front Seat - Grime - Medium / Steering Wheel - Worn, Peel, Crack - Medium / Ceiling - Grime - Large / Sunvisor, Sunglass Holder - Grime - Medium</p>	<p>Remarks (L) Front Fender - Repair Traces - Yes / (R) Mirror - Scratch - Small / (R) Rear Door, Molding - Scratch & Dent - Large / (R) Front Door, Molding - Scratch - Medium / (R) Step, In-panel, Side Spoiler - Scratch & Dent - Small / (R) Rear Fender, Molding - Scratch & Dent - Medium / Rear Bumper, Lamps, Panels - Scratch & Dent - Large / Trunk Hood, Rear Gate - Scratch - Large / (L) Rear Fender, Molding - Scratch - Large / (L) Rear Door, Molding - Scratch - Medium / (L) Front Door, Molding - Scratch - Small / (L) Mirror - Scratch - Medium / (L) Front Fender, Molding - Scratch - Medium / Front Bumper, Grille, Lamps - Scratch & Dent - Large / Bonnet, Headlight - Scratch - Small / (R) Front Fender, Molding - Scratch - Small / Roof - Scratch - Medium</p>

<p>Inspector Notes</p>
<p>Maintenance warning lamp. Aircon issue. Gap at front bumper,bonnet,rear bumper and taillight. scratches on headlight and taillight. Drivebelt noise issue. Without warranty booklet,jack and tools. With spare tire. 1 key. With LTO plate. rear view mirror loose.</p>
