## General Information

| Make | Toyota | Model | Vios |
| YOM | 2024 | Mileage | 9,816 |
| Registration No. | NFR3412 | Chassis No. | PA1B18F33R4252115 |

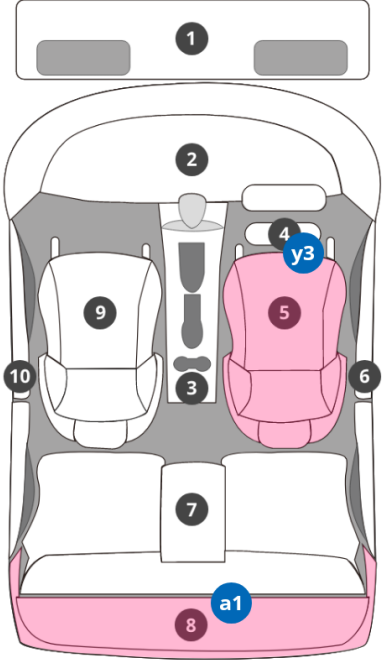
| <b>Remarks</b><br>(R) Front Seat - Grime - Medium / Trunk Room - Worn, Scratch, Cut, Crack - Minimal | <b>Remarks</b><br>Front Bumper, Grille, Lamps - Scratch & Dent - Medium / (L) Mirror - Scratch - Small / Rear Bumper, Lamps, Panels - Scratch - Small / Trunk Hood, Rear Gate - Scratch - Minimal / (L) Front Door, Molding - Scratch - Minimal / (L) Rear Door, Molding - Dent - Small / (L) Rear Fender, Molding - Scratch - Small / (R) Front Fender, Molding - Scratch - Minimal / (R) Front Door, Molding - Scratch - Minimal / (R) Rear Door, Molding - Scratch - Minimal / (R) Rear Fender, Molding - Scratch - Minimal |

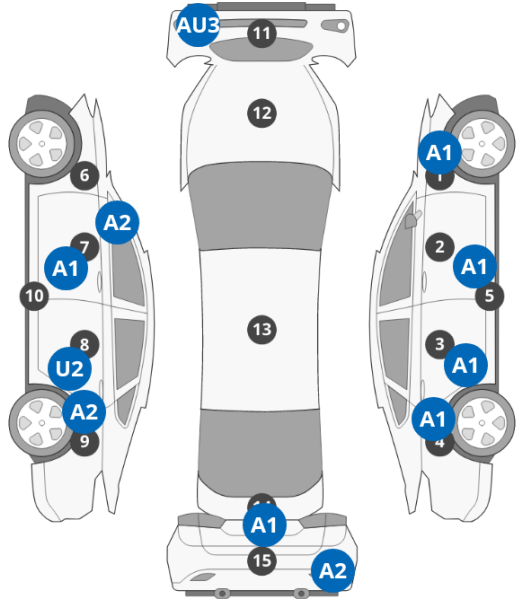
| hairlines scratches around the vehicle/with spare tire/tools/warranty booklet |
