## General Information

| Make | Toyota | Model | Wigo |
| Registration No. | DBR2801 | Chassis No. | MHKAA1BC4RJ026872 |

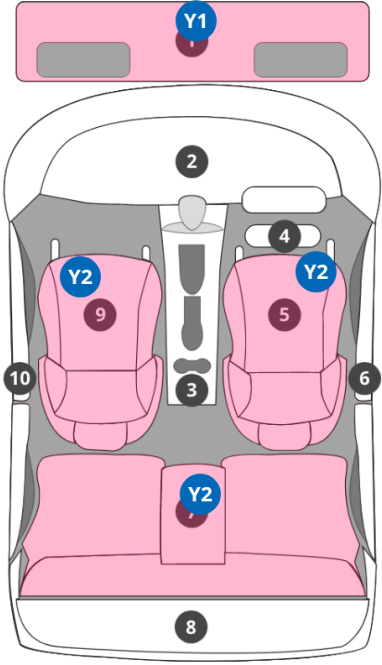
| Interior Evaluation : <b>A</b> | Exterior Evaluation : <b>D</b> |
|---|---|
| <b>Remarks</b><br>Rear Seat - Grime - Small / Ceiling - Grime - Minimal / (R) Front Seat - Grime - Small / (L) Front Seat - Grime - Small | <b>Remarks</b><br>(R) Front Fender, Molding - Scratch & Dent - Large / (R) Front Door, Molding - Scratch & Dent - Large / (R) Rear Door, Molding - Scratch & Dent - Medium / (R) Rear Fender, Molding - Scratch & Dent - Medium / Rear Bumper, Lamps, Panels - Scratch - Small / (L) Rear Fender, Molding - Scratch - Minimal / (L) Rear Door, Molding - Scratch - Minimal / (L) Front Door, Molding - Scratch - Minimal / (L) Mirror - Scratch - Minimal / (L) Front Fender, Molding - Scratch - Minimal / Front Bumper, Grille, Lamps - Scratch - Large / Roof - Scratch - Minimal / Bonnet, Headlight - Scratch - Minimal / (R) Mirror - Scratch - Minimal |
