## General Information

| Make | Toyota | Model | Avanza |

## Body / Panel Condition

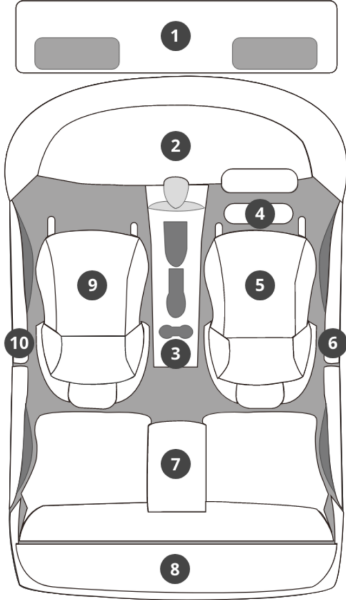
| Interior Evaluation : <span style="color: red; font-weight: bold;">A</span> | Exterior Evaluation : <span style="color: red; font-weight: bold;">C</span> |
|---|---|
| <b>Remarks</b><br>Defects not found | <b>Remarks</b><br>Front Bumper, Grille, Lamps - Scratch - Large / (L) Front Door, Molding - Dent - Minimal / Rear Bumper, Lamps, Panels - Scratch & Dent - Medium / (R) Front Door, Molding - Dent - Minimal |

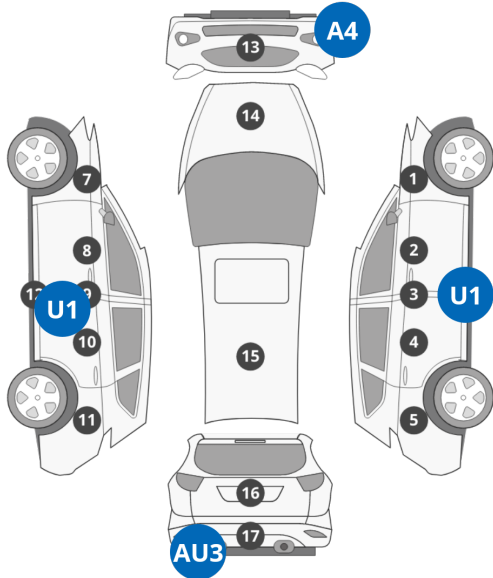
with tools and spare tire/ swirl marks and hairline scratches present on the exterior
