## General Information

| Make | Toyota | Model | Wigo |

## Body / Panel Condition

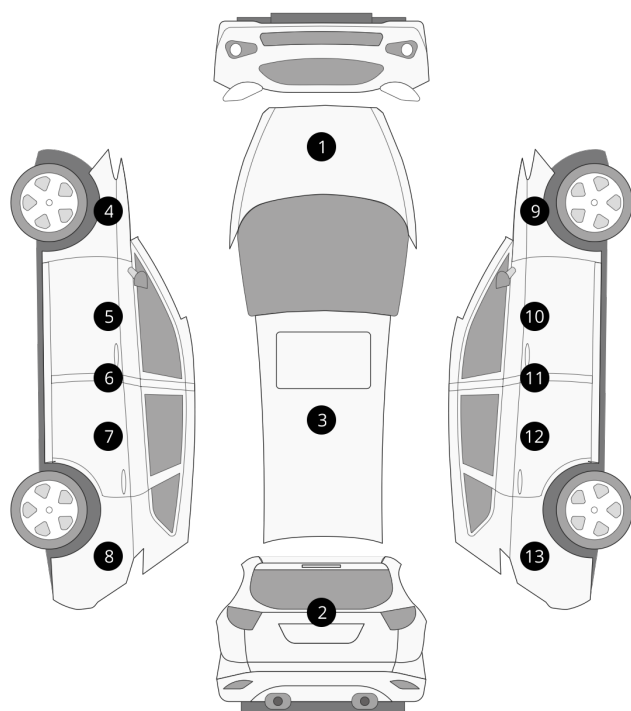
| # | Area | Thickness(um) | | | |
| 1 | Bonnet | 131.3 | 137 | 131 | 126 |
| 2 | Boot Lid | 98.3 | 102 | 98 | 95 |
| 3 | Roof | 94.1 | 90 | 94 | 105/88 |
| 4 | Left Front Fender | 113.0 | 114 | 115 | 110 |
| 5 | Left Front Door | 114.6 | 113 | 112 | 119 |
| 7 | Left Rear Door | 109.6 | 113 | 110 | 106 |
| 8 | Left Back Panel | 110.0 | 111 | 106 | 113 |
| 9 | Right Front Fender | 101.5 | 101 | 100 | 104 |
| 10 | Right Front Door | 106.0 | 114 | 104 | 100 |
| 12 | Right Rear Door | 107.3 | 103 | 103 | 116 |
| 13 | Right Back Panel | 99.1 | 99 | 97 | 101 |

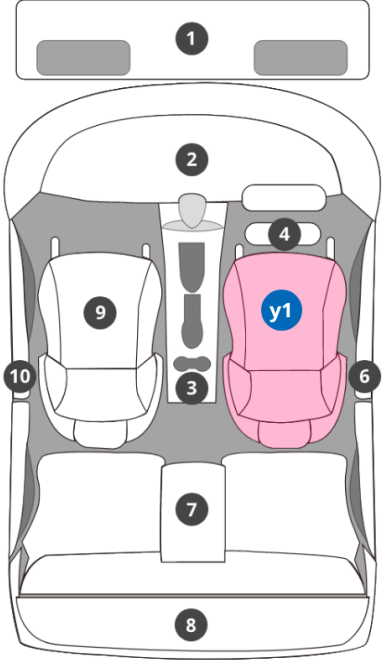
| Interior Evaluation : <span style="color: red; font-weight: bold;">A</span> | Exterior Evaluation : <span style="color: red; font-weight: bold;">A</span> |
| <b>Remarks</b><br>(R) Front Seat - Grime - Minimal | <b>Remarks</b><br>(L) Rear Door, Molding - Dent - Minimal / (R) Rear Door, Molding - Scratch & Dent - Minimal |

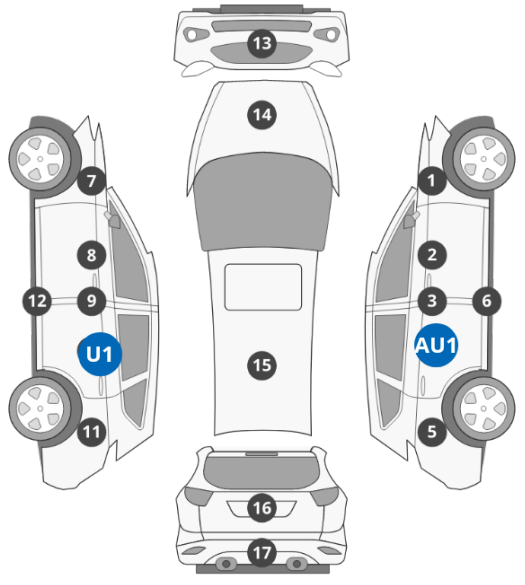
with warranty booklet and user manual. light scratches around the exterior. adhesive marks at the door panels.
