## General Information

| Make | Toyota | Model | Vios |
| YOM | 2021 | Odo Meter Reading | 89,435 |
| Registration No. | NEP4255 | Chassis No. | PA1B18F31M4139000 |

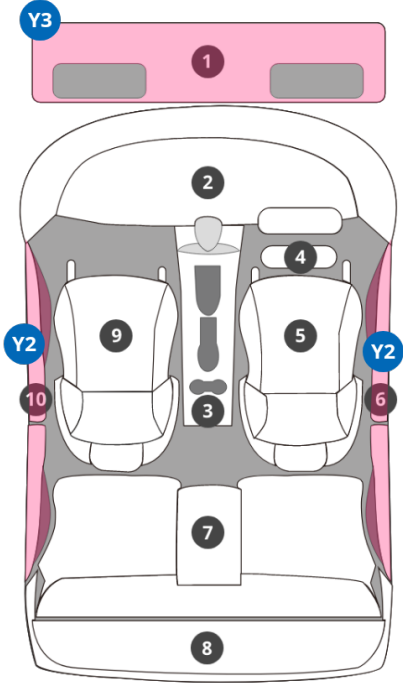
| Interior Evaluation : <span style="color: red;">C</span> | Exterior Evaluation : <span style="color: red;">C</span> |
|---|---|
| <p><b>Remarks</b><br/>Overall Interior - Worn as per age - Yes / Ceiling - Grime - Medium / (R) Front Trim - Grime - Small / (L) Front Trim - Grime - Small</p> | <p><b>Remarks</b><br/>(R) Front Door - Repair Traces - Yes / (R) Front Fender - Repair Traces - Yes / (R) Rear Door - Repair Traces - Yes / Roof - Repair Traces - Yes / (R) Mirror - Scratch - Small / (R) Front Fender, Molding - Dent - Small / (R) Front Door, Molding - Scratch - Minimal / (R) Rear Door, Molding - Dent - Minimal / (R) Rear Fender, Molding - Dent - Medium / Trunk Hood, Rear Gate - Scratch &amp; Dent - Minimal / Rear Bumper, Lamps, Panels - Scratch - Small / (L) Rear Fender, Molding - Scratch - Minimal / (L) Step, In-panel, Side Spoiler - Scratch - Small / (L) Rear Door, Molding - Scratch - Minimal / (L) Front Door, Molding - Repair mark - Yes / (L) Rear Door, Molding - Repair mark - Yes / (L) Front Door, Molding - Scratch - Small / (L) Front Fender, Molding - Scratch - Minimal / Front Bumper, Grille, Lamps - Scratch - Small / Front Bumper, Grille, Lamps - Repair mark - Yes / Bonnet, Headlight - Scratch - Small / Roof - Dent - Small</p> |
