## General Information

| Make | Toyota | Model | Vios |
| YOM | 2021 | Odo Meter Reading | 62,025 |
| Registration No. | NFI3087 | Chassis No. | PA1B18F30M4157018 |

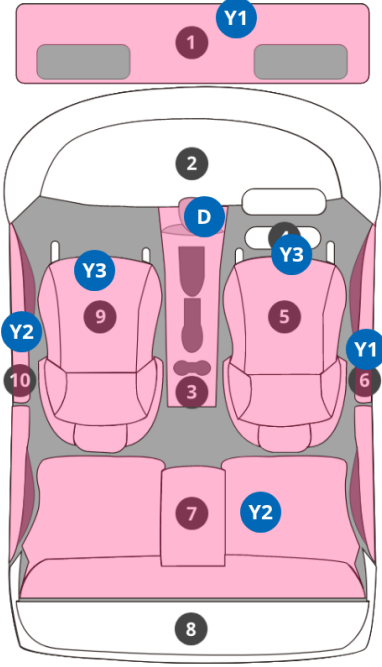
| Interior Evaluation : <b>C</b> | Exterior Evaluation : <b>D</b> |
| <p><b>Remarks</b></p> <p>Overall Interior - Worn as per age - Yes / (R) Front Seat - Grime - Medium / (L) Front Seat - Grime - Medium / Rear Seat - Grime - Small / (R) Front Trim - Grime - Minimal / (L) Front Trim - Grime - Small / Console, Switches, Vents - Traces of Adhesive Tape - Yes / Ceiling - Grime - Minimal</p> | <p><b>Remarks</b></p> <p>(R) Rear Fender - Repair Traces - Yes / (R) Rear Door - Repair Traces - Yes / (R) Front Fender, Molding - Scratch - Small / (R) Mirror - Scratch - Minimal / (R) Front Door, Molding - Scratch - Small / (R) Step, In-panel, Side Spoiler - Scratch - Small / (R) Rear Door, Molding - Scratch - Small / (R) Rear Fender, Molding - Scratch - Small / Rear Bumper, Lamps, Panels - Scratch &amp; Dent - Large / Trunk Hood, Rear Gate - Scratch &amp; Dent - Medium / (L) Rear Fender, Molding - Scratch - Small / (L) Rear Door, Molding - Scratch - Minimal / (L) Step, In-panel, Side Spoiler - Scratch &amp; Dent - Small / (L) Front Door, Molding - Scratch - Small / (L) Mirror - Scratch - Small / (L) Front Fender, Molding - Scratch - Small / Member (Bolted) - Dent - Yes / Front Bumper, Grille, Lamps - Scratch &amp; Dent - Medium / Bonnet, Headlight - Scratch - Minimal / Roof - Scratch - Minimal</p> |
