## General Information

| Make | Toyota | Model | Avanza |
| Registration No. | NHC9348 | Chassis No. | MHFAA1BY8N0010278 |

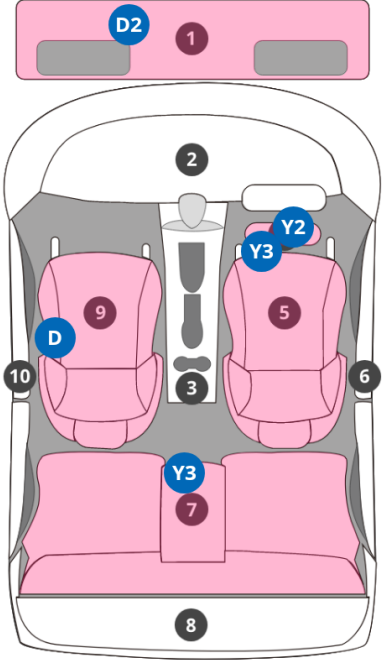
| <b>Remarks</b><br>Rear Seat - Grime - Medium / (R) Front Seat - Grime - Medium / (R) Front Floor Mat - Grime - Small / Ceiling - Crinkle - Small / (L) Front Seat - Worn - Yes | <b>Remarks</b><br>(R) Mirror - Scratch - Minimal / (R) Front Fender, Molding - Scratch - Minimal / (R) Front Door, Molding - Scratch - Small / (R) Rear Door, Molding - Scratch - Small / (R) Rear Fender, Molding - Scratch - Medium / Rear Bumper, Lamps, Panels - Repair mark - Yes / Rear Bumper, Lamps, Panels - Scratch - Small / Trunk Hood, Rear Gate - Scratch - Minimal / (L) Rear Fender, Molding - Scratch - Small / (L) Rear Door, Molding - Scratch - Small / (L) Step, In-panel, Side Spoiler - Scratch - Small / (L) Front Door, Molding - Scratch - Minimal / (L) Mirror - Scratch - Minimal / (L) Front Fender, Molding - Scratch - Minimal / Front Bumper, Grille, Lamps - Scratch - Medium / Bonnet, Headlight - Scratch - Small / Roof - Scratch - Minimal |

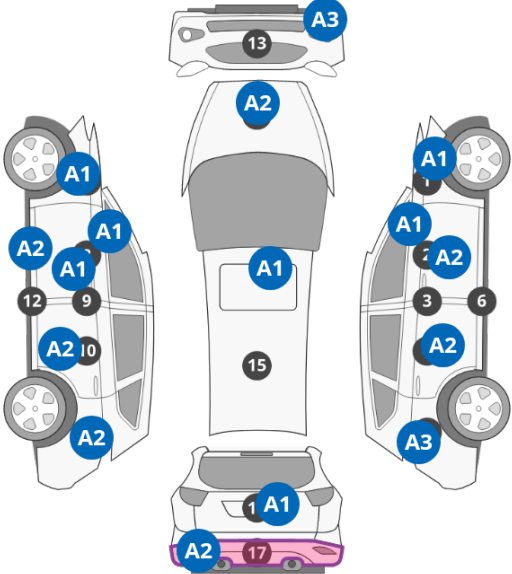
| Inspector Notes |
|---|
| with warranty booklet, with jack and tools, with spare tire, with LTO plate, scratches on tail light |
