## General Information

| Make | Toyota | Model | Vios |
| YOM | 2024 | Odo Meter Reading | 37,964 |
| Registration No. | NHM7087 | Chassis No. | PA1B18F39R4241071 |

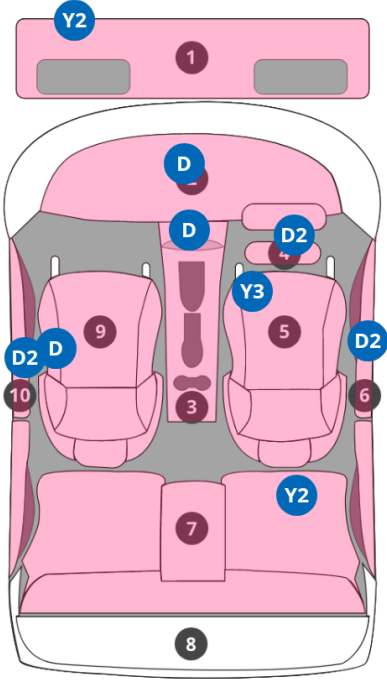
| Interior Evaluation : <b>C</b> | Exterior Evaluation : <b>C</b> |
|---|---|
| <p><b>Remarks</b></p> <p>(R) Front Seat - Grime - Medium / (L) Front Seat - Worn - Yes / Rear Seat - Grime - Small / (R) Front Trim - Worked - Small / (L) Front Trim - Worked - Small / (L) Front Floor Mat - Worked - Small / Dashboard - Traces of Adhesive Tape - Yes / Console, Switches, Vents - Traces of Adhesive Tape - Yes / Ceiling - Grime - Small</p> | <p><b>Remarks</b></p> <p>(L) Rear Fender - Repair Traces - Yes / (R) Rear Door - Repair Traces - Yes / (R) Front Fender, Molding - Scratch - Small / (R) Mirror - Scratch - Minimal / (R) Front Door, Molding - Scratch &amp; Dent - Small / (R) Rear Door, Molding - Scratch - Small / (R) Rear Fender, Molding - Scratch - Small / Rear Bumper, Lamps, Panels - Scratch - Small / Trunk Hood, Rear Gate - Scratch - Small / (L) Rear Fender, Molding - Scratch &amp; Dent - Minimal / (L) Rear Door, Molding - Repair mark - Yes / (L) Rear Door, Molding - Scratch &amp; Dent - Medium / (L) Front Door, Molding - Scratch - Small / (L) Mirror - Scratch - Minimal / Front Bumper, Grille, Lamps - Scratch - Small / Bonnet, Headlight - Scratch - Minimal / Roof - Scratch - Minimal</p> |

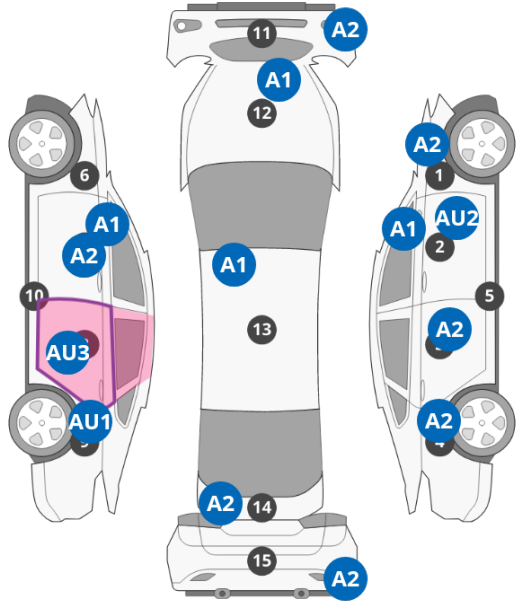
| Inspector Notes |
|---|
| no warranty booklet, no jack and tools, no spare tire, with LTO plate, scratches on tail light |
