## General Information

| Make | Toyota | Model | Hiace |

## Body / Panel Condition

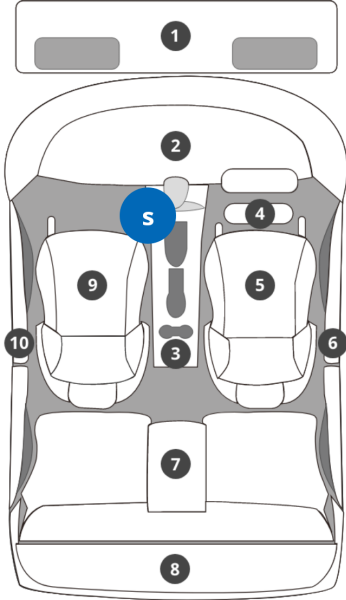
| Interior Evaluation : <span style="color: red;">B</span> | Exterior Evaluation : <span style="color: red;">C</span> |
| <b>Remarks</b><br>Overall Interior - Smell - Yes | <b>Remarks</b><br>Trunk Hood, Rear Gate - Scratch - Small / (R) Front Fender, Molding - Dent - Small / (L) Rear Door, Molding - Dent - Small / Rear Bumper, Lamps, Panels - Scratch - Large |

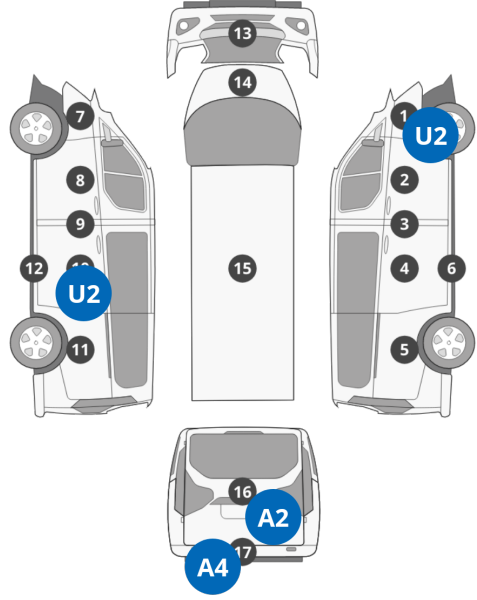
| Inspector Notes |
|---|
| swirl marks and hairline scratches present around the exterior/ no tools, jack, and warranty booklet/ no reverse camera feature |
