## General Information

| Make | Toyota | Model | Vios |
| YOM | 2024 | Odo Meter Reading | 21,296 |

## Body / Panel Condition

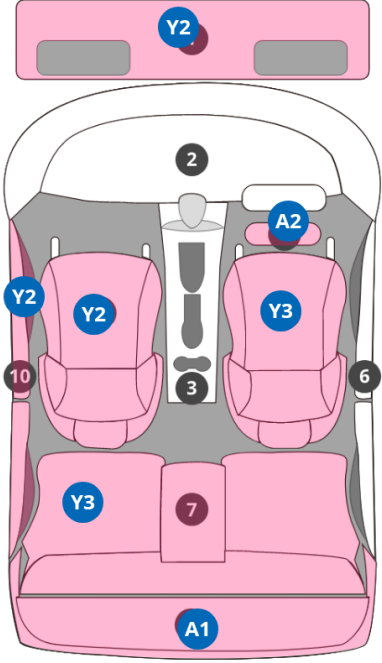
| Interior Evaluation : <b>B</b> | Exterior Evaluation : <b>E</b> |
|---|---|
| <p><b>Remarks</b><br/>(R) Front Seat - Grime - Medium / Rear Seat - Grime - Medium / (L) Front Seat - Grime - Small / Ceiling - Grime - Small / (L) Front Floor Mat - Cut, Crack - Small / (L) Front Trim - Grime - Small / Trunk Room - Worn, Scratch, Cut, Crack - Minimal</p> | <p><b>Remarks</b><br/>(R) Rear Fender, Molding - Scratch - Small / (R) Rear Door, Molding - Scratch &amp; Dent - Large / (R) Front Door, Molding - Scratch &amp; Dent - Medium / (R) Step, In-panel, Side Spoiler - Scratch &amp; Dent - Medium / (R) Front Fender, Molding - Scratch - Medium / Front Bumper, Grille, Lamps - Scratch - Large / (L) Front Fender, Molding - Scratch &amp; Dent - Medium / (L) Front Door, Molding - Scratch - Small / (L) Rear Door, Molding - Scratch - Large / (L) Rear Fender, Molding - Scratch - Medium / Rear Bumper, Lamps, Panels - Scratch &amp; Dent - Small / Trunk Hood, Rear Gate - Scratch - Small / Roof - Dent - Small</p> |
