## General Information

| Make | Toyota | Model | Vios |
| YOM | 2024 | Odo Meter Reading | 19,499 |
| Registration No. | DBM8898 | Chassis No. | PA1B18F33R4246895 |

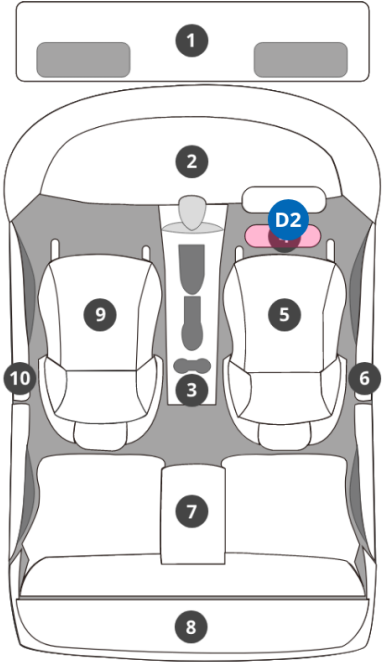
| Interior Evaluation : <span style="color: red; font-weight: bold;">A</span> | Exterior Evaluation : <span style="color: red; font-weight: bold;">C</span> |
|---|---|
| <b>Remarks</b><br>(L) Front Floor Mat - Worked - Small | <b>Remarks</b><br>(R) Front Door, Molding - Scratch & Dent - Small / (R) Rear Fender, Molding - Dent - Small / (R) Rear Door, Molding - Scratch - Small / (R) Front Fender, Molding - Scratch - Minimal / Bonnet, Headlight - Scratch - Small / Front Bumper, Grille, Lamps - Scratch - Small / Member (Bolted) - Dent - Yes / (L) Front Fender, Molding - Scratch - Minimal / (L) Front Door, Molding - Scratch - Small / (L) Rear Door, Molding - Scratch - Small / (L) Rear Fender, Molding - Scratch - Minimal / Rear Bumper, Lamps, Panels - Scratch - Small / Trunk Hood, Rear Gate - Scratch - Small / Roof - Scratch - Minimal |
