## General Information

| Make | Toyota | Model | Vios |

## Body / Panel Condition

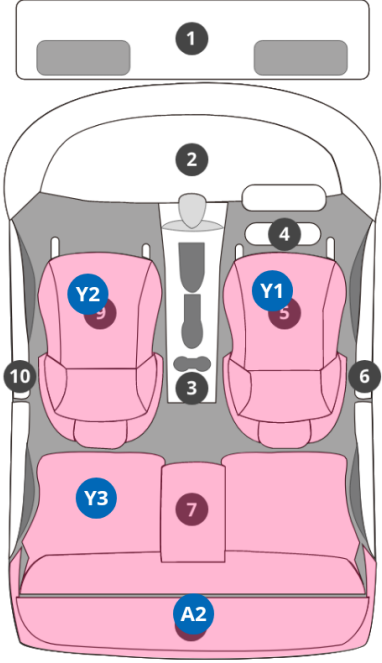
| <b>Interior Evaluation :</b> <b>B</b> | <b>Exterior Evaluation :</b> <b>D</b> |
| <b>Remarks</b><br>Trunk Room - Worn, Scratch, Cut, Crack - Small / Rear Seat - Grime - Medium / (R) Front Seat - Grime - Minimal / (L) Front Seat - Grime - Small | <b>Remarks</b><br>(R) Front Fender, Molding - Scratch & Dent - Small / (R) Front Door, Molding - Scratch - Medium / (R) Rear Door, Molding - Scratch - Small / (R) Rear Fender, Molding - Scratch & Dent - Large / Rear Bumper, Lamps, Panels - Scratch - Medium / (L) Rear Fender, Molding - Scratch - Small / Trunk Hood, Rear Gate - Scratch & Dent - Minimal / (L) Rear Door, Molding - Scratch - Small / (L) Front Door, Molding - Scratch - Minimal / (L) Mirror - Scratch - Minimal / (L) Front Fender, Molding - Scratch - Minimal / Front Bumper, Grille, Lamps - Scratch - Large / Bonnet, Headlight - Scratch - Small / Roof - Scratch - Minimal |
