## General Information

| Make | Toyota | Model | Vios |

## Body / Panel Condition

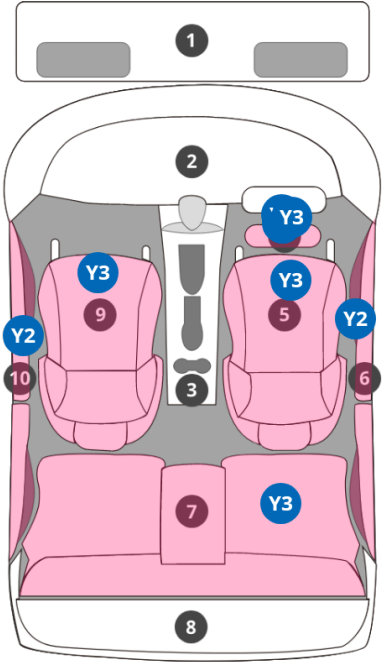
| Interior Evaluation : <span style="color: red;">C</span> | Exterior Evaluation : <span style="color: red;">D</span> |
| <b>Remarks</b><br>Mat Other - Grime - Medium / Rear Seat - Grime - Medium / (R) Front Trim - Grime - Small / (R) Front Seat - Grime - Medium / (L) Front Seat - Grime - Medium / (R) Front Floor Mat - Grime - Medium / (L) Front Floor Mat - Grime - Medium / (L) Front Trim - Grime - Small | <b>Remarks</b><br>(R) Front Fender, Molding - Scratch - Medium / (R) Front Door, Molding - Scratch - Minimal / (R) Rear Door, Molding - Scratch - Small / (R) Rear Fender, Molding - Scratch - Medium / Rear Bumper, Lamps, Panels - Scratch - Small / Trunk Hood, Rear Gate - Scratch - Minimal / (L) Rear Fender, Molding - Scratch - Small / (L) Rear Door, Molding - Scratch - Small / (L) Front Door, Molding - Scratch - Small / (L) Step, In-panel, Side Spoiler - Scratch - Small / (L) Front Fender, Molding - Scratch - Minimal / Front Bumper, Grille, Lamps - Scratch - Large / Bonnet, Headlight - Scratch - Small / Roof - Scratch - Minimal |

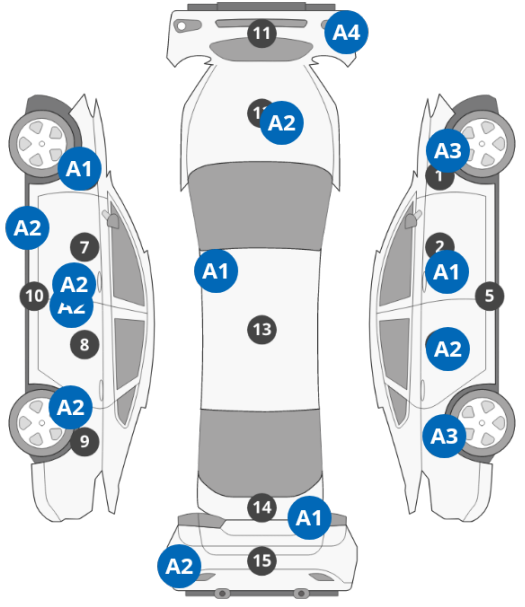
no warranty booklet, with jack and tools, with spare tire, with LTO plate, scratches on tail light, trunk room latch issue
