## General Information

| Make | Toyota | Model | Vios |
| YOM | 2024 | Odo Meter Reading | 61,450 |
| Registration No. | NIU8156 | Chassis No. | PA1B18F35R4245876 |

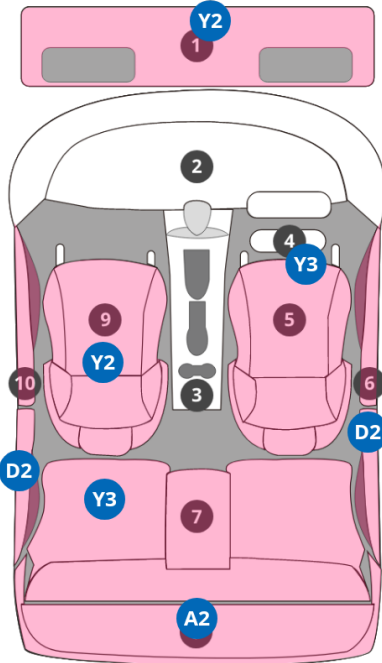
| <b>Remarks</b><br>Trunk Room - Worn, Scratch, Cut, Crack - Small / Rear Seat - Grime - Medium / (L) Rear Trim - Worked - Small / Ceiling - Grime - Small / (R) Rear Trim - Worked - Small / (R) Front Seat - Grime - Medium / (L) Front Seat - Grime - Small | <b>Remarks</b><br>(L) Front Fender - Repair Traces - Yes / (L) Front Door - Repair Traces - Yes / (R) Rear Door - Repair Traces - Yes / (L) Front Fender, Molding - Repair mark - Yes / (L) Front Door, Molding - Repair mark - Yes / (R) Rear Door, Molding - Repair mark - Yes / (R) Front Fender, Molding - Repair mark - Yes / (R) Front Fender, Molding - Scratch - Minimal / (R) Mirror - Scratch - Medium / (R) Front Door, Molding - Scratch - Minimal / (R) Rear Door, Molding - Scratch - Minimal / (R) Rear Fender, Molding - Scratch - Small / Rear Bumper, Lamps, Panels - Repair mark - Yes / Rear Bumper, Lamps, Panels - Scratch - Medium / Trunk Hood, Rear Gate - Scratch - Minimal / (L) Rear Fender, Molding - Scratch - Minimal / (L) Rear Door, Molding - Dent - Minimal / (L) Front Door, Molding - Scratch - Small / (L) Front Fender, Molding - Scratch - Minimal / Front Bumper, Grille, Lamps - Repair mark - Yes / Front Bumper, Grille, Lamps - Scratch - Medium / Overall Exterior - Faded(Color, Gloss) - Yes / Bonnet, Headlight - Scratch - Minimal / Roof - Scratch - Minimal |
