## General Information

| Make | Toyota | Model | Vios |
| YOM | 2024 | Odo Meter Reading | 11,158 |
| Registration No. | NHM4135 | Chassis No. | PA1B18F31R4239869 |

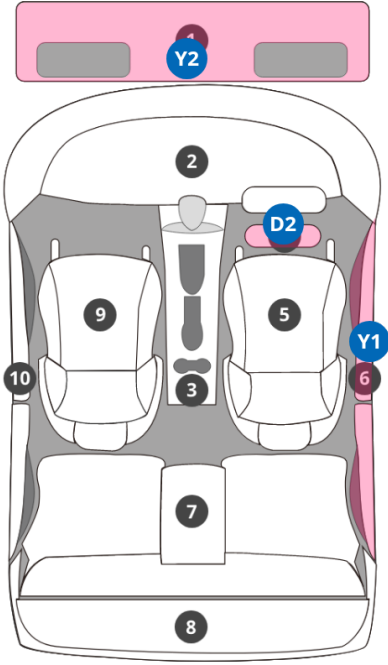
| Interior Evaluation : <b>A</b> | Exterior Evaluation : <b>B</b> |
|---|---|
| <b>Remarks</b><br>Ceiling - Grime - Small / (L) Front Floor Mat - Worked - Small / (R) Front Trim - Grime - Minimal | <b>Remarks</b><br>(L) Rear Fender - Repair Traces - Yes / (R) Front Fender, Molding - Scratch - Minimal / (R) Front Door, Molding - Dent - Minimal / (R) Rear Door, Molding - Scratch - Minimal / Rear Bumper, Lamps, Panels - Scratch - Small / Trunk Hood, Rear Gate - Crack, Gap - Medium / (L) Rear Fender, Molding - Dent - Minimal / (L) Rear Door, Molding - Scratch - Minimal / (L) Front Door, Molding - Scratch - Minimal / (L) Front Fender, Molding - Scratch - Minimal / Front Bumper, Grille, Lamps - Scratch - Small / Bonnet, Headlight - Scratch - Minimal / Roof - Dent - Minimal |
