## General Information

| Make | Toyota | Model | Lite Ace |
| Registration No. | DBM3069 | Chassis No. | MHKU3FE10PK005952 |

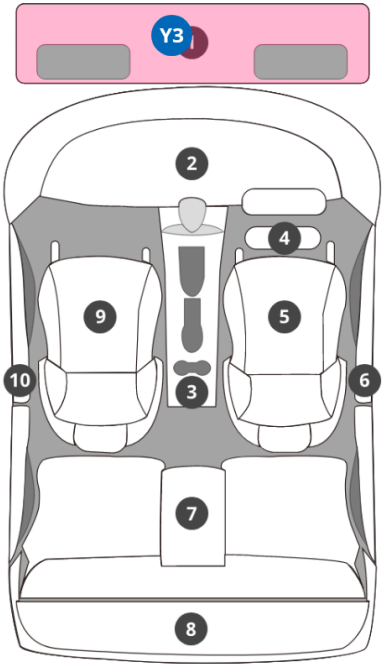
| <b>Remarks</b><br>Ceiling - Grime - Medium | <b>Remarks</b><br>(R) Front Fender, Molding - Scratch - Minimal / (R) Front Door, Molding - Scratch - Minimal / (R) Side Gate - Scratch - Large / Rear Gate - Scratch - Small / (L) Side Gate - Scratch & Dent - Large / Rear Bumper, Lamps, Panels - Dent - Medium / Roof - Dent - Medium / Cargo Bed Floor - Scratch - Large / (L) Front Door, Molding - Scratch - Minimal / (L) Front Fender, Molding - Scratch - Minimal / Front Bumper, Grille, Lamps - Scratch - Medium / Front Panel - Scratch - Small |
