## General Information

| Make | Toyota | Model | Innova |
| Registration No. | DBO1716 | Chassis No. | PA2JA8EM2P0134658 |

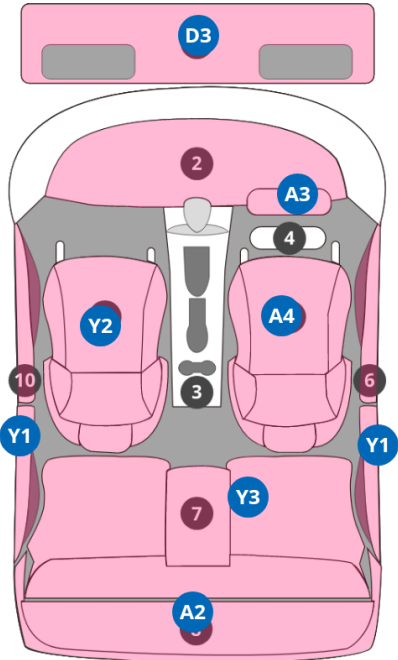
| <b>Interior Evaluation :</b> <span style="color: red; font-weight: bold;">C</span> | <b>Exterior Evaluation :</b> <span style="color: red; font-weight: bold;">E</span> |
| <b>Remarks</b><br>(R) Front Seat - Cut, Crack - Large / Ceiling - Crinkle - Medium / Rear Seat - Grime - Medium / Trunk Room - Worn, Scratch, Cut, Crack - Small / (L) Rear Trim - Grime - Minimal / (R) Rear Trim - Grime - Minimal / Steering Wheel - Worn, Peel, Crack - Medium / (L) Front Seat - Grime - Small | <b>Remarks</b><br>Rear Bumper, Lamps, Panels - Scratch - Small / (L) Rear Door, Molding - Crack, Gap - Small / (L) Step, In-panel, Side Spoiler - Scratch - Small / (L) Front Fender, Molding - Dent - Large / Front Bumper, Grille, Lamps - Crack, Gap - Large / Bonnet, Headlight - Scratch & Dent - Large / (R) Front Fender, Molding - Crack, Gap - Large / (R) Front Door, Molding - Scratch - Small / (R) Step, In-panel, Side Spoiler - Scratch - Minimal / (R) Rear Door, Molding - Scratch & Dent - Small / Roof - Dent - Small / Front Windshield - Damaged - Large / (L) Mirror - Scratch - Small / (L) Front Door, Molding - Scratch & Dent - Small |

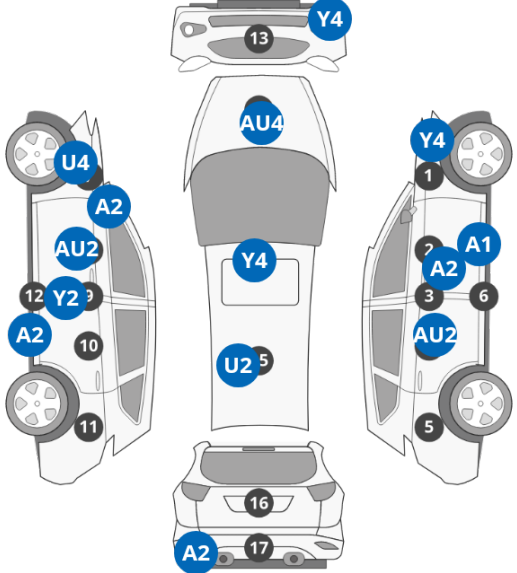
with LTO plate/with spare tire/with jack and tools/No warranty booklet/left and right door was damage/engine number unable to confirm/windshield damage /right side headlights crack
