## General Information

| Make | Toyota | Model | Vios |
| YOM | 2024 | Odo Meter Reading | 54,879 |
| Registration No. | DBN9730 | Chassis No. | PA1B18F34P4237507 |

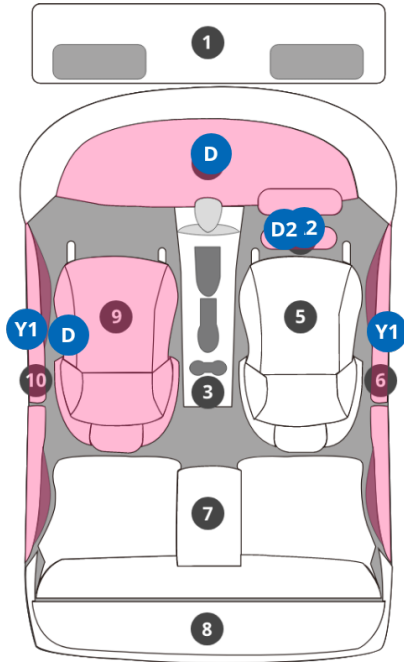
| Interior Evaluation : <b>B</b> | Exterior Evaluation : <b>D</b> |
| <p><b>Remarks</b></p> <p>(L) Front Floor Mat - Cut, Crack - Small / (L) Front Floor Mat - Worked - Small / (L) Front Seat - Worn - Yes / (R) Front Trim - Grime - Minimal / Dashboard - Traces of Adhesive Tape - Yes / (L) Front Trim - Grime - Minimal</p> | <p><b>Remarks</b></p> <p>(R) Front Fender, Molding - Scratch - Small / (R) Mirror - Scratch - Small / (R) Step, In-panel, Side Spoiler - Scratch &amp; Dent - Medium / (R) Rear Door, Molding - Scratch &amp; Dent - Medium / (R) Rear Fender, Molding - Scratch &amp; Dent - Small / (R) Front Door, Molding - Scratch &amp; Dent - Minimal / Rear Bumper, Lamps, Panels - Scratch - Small / Trunk Hood, Rear Gate - Scratch - Small / (L) Rear Fender, Molding - Scratch - Minimal / (L) Rear Door, Molding - Scratch - Medium / (L) Front Door, Molding - Scratch - Small / Front Bumper, Grille, Lamps - Scratch - Small / Bonnet, Headlight - Scratch - Small / Roof - Scratch - Small</p> |

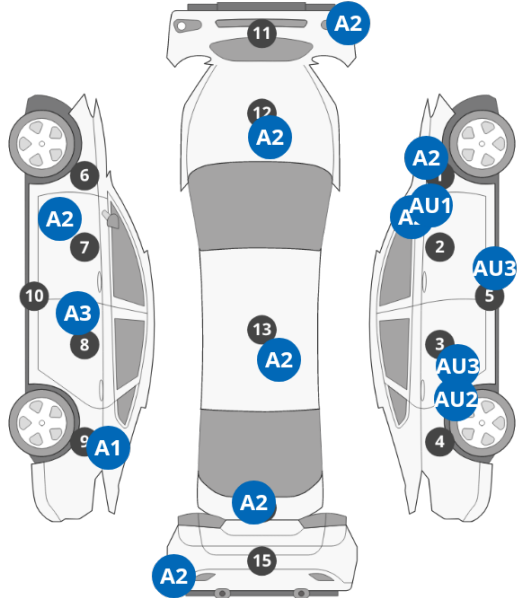
| Inspector Notes |
|---|
| no warranty booklet, with jack and tools, with spare tire, with LTO plate, scratches on tail light |
