## General Information

| Make | Toyota | Model | Vios |
| YOM | 2024 | Mileage | 23,436 |
| Registration No. | DBN5332 | Chassis No. | PA1B18F34P4231495 |

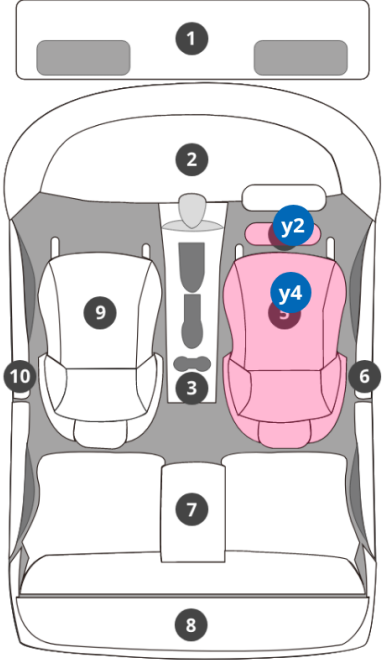
| <b>Remarks</b><br>(L) Front Floor Lag - Grime - Small / (R) Front Seat - Grime - Large | <b>Remarks</b><br>(R) Front Fender, Molding - Scratch - Minimal / (R) Front Door, Molding - Scratch - Minimal / (R) Rear Door, Molding - Scratch - Minimal / (R) Rear Fender, Molding - Dent - Minimal / Trunk Hood, Rear Gate - Scratch - Minimal / (L) Rear Door, Molding - Scratch - Small / (L) Front Door, Molding - Scratch - Minimal / (L) Front Fender, Molding - Scratch - Minimal / Front Bumper, Grille, Lamps - Scratch - Minimal / Bonnet, Headlight - Scratch - Minimal |
