## General Information

| Make | Toyota | Model | Vios |
| Registration No. | NIT5465 | Chassis No. | PA1B18F34P4231349 |

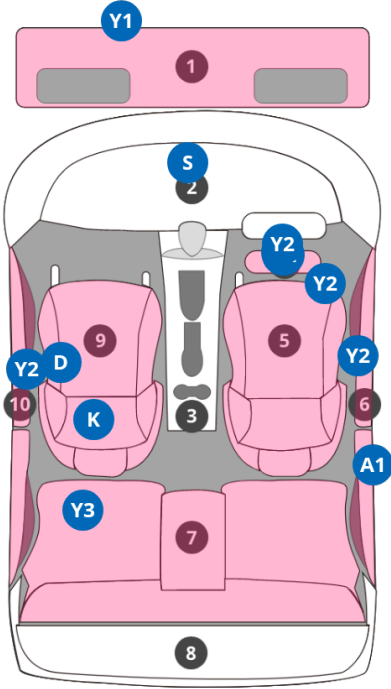
| Interior Evaluation : <b>C</b> | Exterior Evaluation : <b>E</b> |
|---|---|
| <p><b>Remarks</b></p> <p>Rear Seat - Grime - Medium / (L) Front Floor Mat - Cut, Crack - Small / Carpet - Worn, Scratch, Cut, Crack - Small / Mat Other - Grime - Small / (L) Front Seat - Worn - Yes / Overall Interior - Animal Hair - Yes / (R) Front Seat - Grime - Small / (R) Rear Trim - Cut, Crack - Minimal / (R) Front Trim - Grime - Small / (R) Front Floor Mat - Grime - Small / (L) Front Trim - Grime - Small / Overall Interior - Smell - Yes / Ceiling - Grime - Minimal</p> | <p><b>Remarks</b></p> <p>(R) Front Fender, Molding - Scratch - Small / (R) Mirror - Scratch - Small / (R) Front Door, Molding - Scratch &amp; Dent - Large / (R) Rear Door, Molding - Scratch &amp; Dent - Medium / (R) Rear Fender, Molding - Repair mark - Yes / (R) Rear Fender, Molding - Dent - Small / Trunk Hood, Rear Gate - Scratch - Small / Rear Bumper, Lamps, Panels - Scratch &amp; Dent - Medium / Rear Bumper, Lamps, Panels - Repair mark - Yes / (R) Rear Door, Molding - Repair mark - Yes / (L) Rear Fender, Molding - Scratch - Minimal / (L) Rear Door, Molding - Scratch - Small / (L) Front Door, Molding - Scratch - Small / (L) Mirror - Scratch - Minimal / (L) Front Fender, Molding - Scratch &amp; Dent - Small / Front Bumper, Grille, Lamps - Scratch - Medium / Member (Bolted) - Dent - Yes / Bonnet, Headlight - Scratch - Minimal / Roof - Scratch - Small</p> |

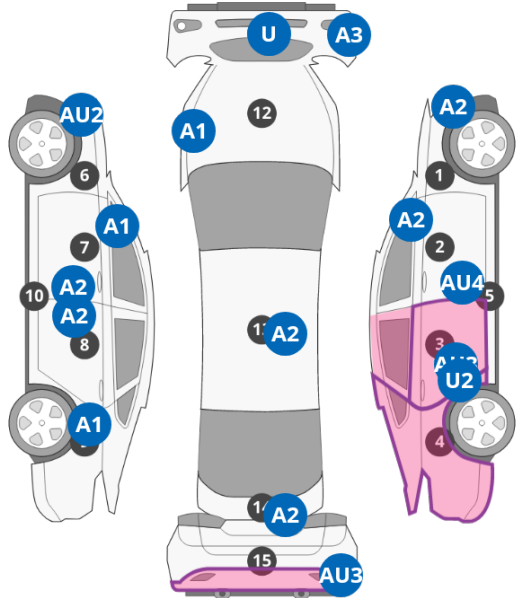
| Inspector Notes |
|---|
| no warranty booklet, no jack and tools, with spare tire, with LTO plate, weak battery, scratches on tail light, cracked tail light |
