## General Information

| Make | Toyota | Model | Vios |
| Registration No. | DBN3966 | Chassis No. | PA1B18F3XP4229024 |

## Body / Panel Condition

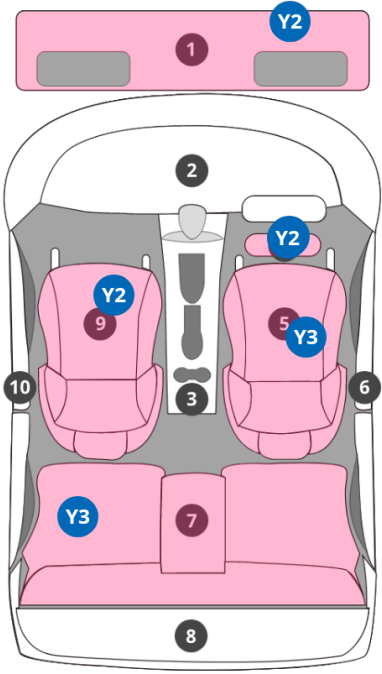
| Interior Evaluation : <b>B</b> | Exterior Evaluation : <b>E</b> |
|---|---|
| <p><b>Remarks</b><br/>(L) Front Floor Mat - Worked - Small / Rear Seat - Grime - Medium / (R) Front Floor Mat - Grime - Small / (L) Front Seat - Grime - Small / Ceiling - Grime - Small / (R) Front Seat - Grime - Medium</p> | <p><b>Remarks</b><br/>Bonnet - Repair Traces - Yes / (L) Front Door, Molding - Scratch &amp; Dent - Medium / Bonnet, Headlight - Repair mark - Yes / (L) Step, In-panel, Side Spoiler - Scratch &amp; Dent - Small / (L) Front Fender, Molding - Scratch &amp; Dent - Medium / Member (Bolted) - Dent - Yes / (R) Front Fender, Molding - Scratch &amp; Dent - Large / (R) Front Door, Molding - Scratch &amp; Dent - Medium / (R) Rear Door, Molding - Scratch - Medium / Rear Bumper, Lamps, Panels - Scratch - Small / (L) Rear Fender, Molding - Scratch - Small / Front Bumper, Grille, Lamps - Scratch - Small / Roof - Scratch - Small / Bonnet, Headlight - Scratch - Small / (L) Rear Door, Molding - Scratch - Minimal / (R) Rear Fender, Molding - Scratch - Small</p> |

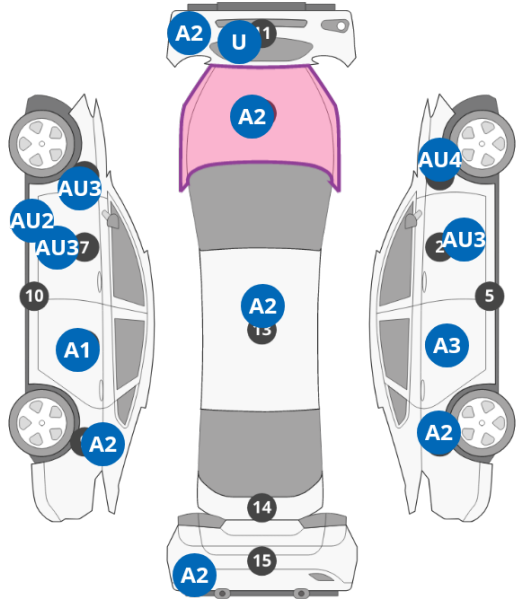
| Inspector Notes |
|---|
| with Sparetire and Jack, Incomplete Tools. no warranty booklet and LTO Plate, scratch headlight and tail light. |
