## General Information

| Make | Toyota | Model | Vios |
| YOM | 2023 | Odo Meter Reading | 30,842 |

## Body / Panel Condition

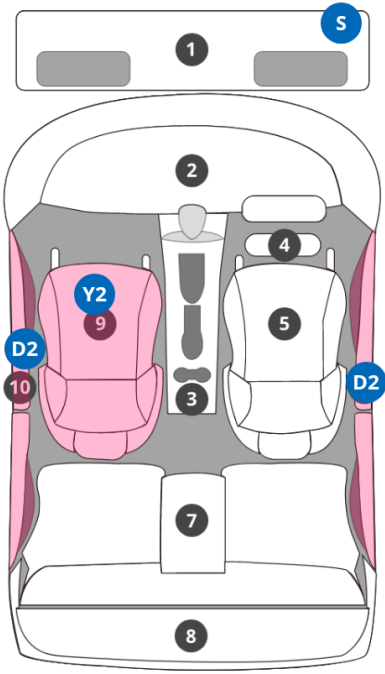
| Interior Evaluation : <b>B</b> | Exterior Evaluation : <b>D</b> |
|---|---|
| <p><b>Remarks</b><br/>(L) Front Seat - Grime - Small / (L) Front Trim - Worked - Small / (R) Front Trim - Worked - Small / Overall Interior - Smell - Yes</p> | <p><b>Remarks</b><br/>Trunk Hood, Rear Gate - Scratch &amp; Dent - Medium / Rear Bumper, Lamps, Panels - Scratch &amp; Dent - Small / (R) Step, In-panel, Side Spoiler - Dent - Small / (R) Rear Fender, Molding - Scratch - Small / (R) Rear Door, Molding - Scratch &amp; Dent - Medium / (R) Front Door, Molding - Scratch &amp; Dent - Small / Member (Bolted) - Dent - Yes / Front Bumper, Grille, Lamps - Scratch - Small / (R) Front Fender, Molding - Scratch - Small / (L) Mirror - Scratch - Minimal / (R) Mirror - Scratch - Minimal / (L) Rear Fender, Molding - Scratch &amp; Dent - Small / (L) Rear Door, Molding - Scratch - Small / (L) Front Door, Molding - Scratch - Minimal / (L) Front Fender, Molding - Scratch - Minimal / Bonnet, Headlight - Scratch &amp; Dent - Small / Roof - Scratch - Minimal / (R) Rear Door, Molding - Repair mark - Yes</p> |

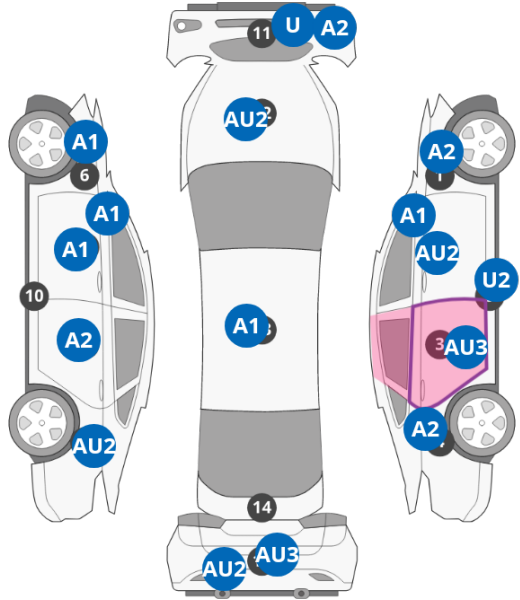
| Inspector Notes |
|---|
| With warranty booklet and LTO Plate, Jack and Sparetire, Incomplete Tools. scratch headlight and tail light. Crack left tail light. worm tires. |
