## General Information

| Make | Toyota | Model | Vios |
| Registration No. | NHI8635 | Chassis No. | PA1B18F32P4207941 |

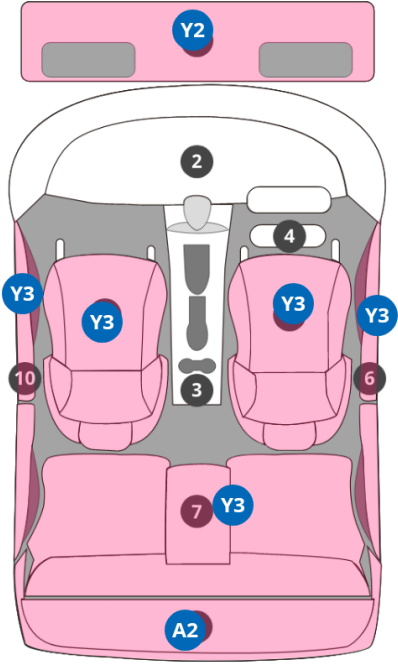
| <b>Remarks</b><br>(R) Front Seat - Grime - Medium / (R) Front Trim - Grime - Medium / Rear Seat - Grime - Medium / Trunk Room - Worn, Scratch, Cut, Crack - Small / (L) Front Seat - Grime - Medium / (L) Front Trim - Grime - Medium / Ceiling - Grime - Small | <b>Remarks</b><br>Rear Bumper, Lamps, Panels - Scratch - Small / Trunk Hood, Rear Gate - Scratch - Minimal / (R) Rear Fender, Molding - Scratch & Dent - Small / (R) Rear Door, Molding - Scratch - Medium / (R) Front Door, Molding - Scratch - Small / (R) Front Fender, Molding - Scratch - Minimal / Front Bumper, Grille, Lamps - Scratch - Medium / (L) Front Fender, Molding - Scratch - Minimal / (L) Rear Door, Molding - Scratch - Minimal / (L) Rear Fender, Molding - Scratch - Small |
