## General Information

| Make | Toyota | Model | Vios |
| YOM | 2023 | Odo Meter Reading | 80,151 |
| Registration No. | NHI7495 | Chassis No. | PA1B18F38P4207720 |

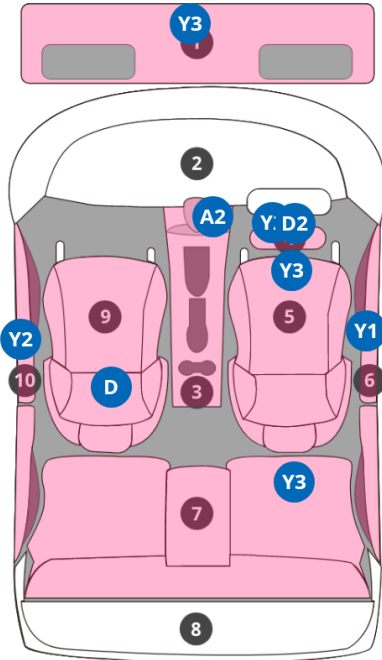
| <b>Interior Evaluation :</b> <span style="color: red; font-weight: bold;">C</span> | <b>Exterior Evaluation :</b> <span style="color: red; font-weight: bold;">C</span> |
| <b>Remarks</b><br>Overall Interior - Worn as per age - Yes / (L) Front Seat - Worn - Yes / (R) Front Seat - Grime - Medium / Mat Other - Grime - Small / Rear Seat - Grime - Medium / (R) Front Trim - Grime - Minimal / (L) Front Trim - Grime - Small / Console, Switchs, Vents - Worn, Scratch, Cut, Crack - Small / Ceiling - Grime - Medium / (L) Front Floor Mat - Worked - Small | <b>Remarks</b><br>(L) Front Fender - Repair Traces - Yes / (R) Rear Fender - Repair Traces - Yes / (R) Front Fender, Molding - Scratch - Minimal / (R) Mirror - Scratch - Minimal / (R) Front Door, Molding - Scratch - Minimal / (R) Rear Door, Molding - Scratch - Small / (R) Rear Fender, Molding - Scratch - Minimal / Rear Bumper, Lamps, Panels - Scratch - Small / Trunk Hood, Rear Gate - Dent - Small / (L) Rear Fender, Molding - Scratch - Small / (L) Rear Door, Molding - Scratch - Small / (L) Mirror - Scratch - Small / (L) Front Door, Molding - Scratch - Small / (L) Front Fender, Molding - Scratch - Minimal / Member (Bolted) - Dent - Yes / Front Bumper, Grille, Lamps - Scratch & Dent - Medium / Bonnet, Headlight - Scratch - Minimal / Roof - Scratch - Small |

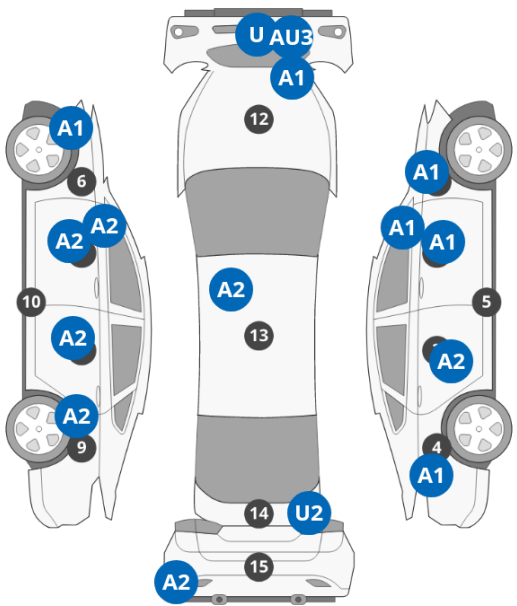
| <p><b>a</b> : Cut, Fray <b>d</b> : Loose, Deformed <b>k</b> : Animal Hair <b>s</b> : Smell <b>t</b> : Cigarette Burns <b>x</b> : Defective <b>y</b> : Stain</p> | <p><b>A</b> : Scratch <b>AU</b> : Scratch &amp; Dent <b>B</b> : Modified <b>C</b> : Corrosion <b>G</b> : Stone chip <b>P</b> : Faded <b>S</b> : Rust <b>SC</b> : Rust &amp; Corrosion <b>U</b> : Dent <b>X</b> : Defective <b>Y</b> : Crack, Gap</p> |

| Inspector Notes |
|---|
| no warranty booklet, no jack, incomplete tools, with spare tire, with LTO plate, scratches on tail light |
