## General Information

| Make | Toyota | Model | Vios |

## Body / Panel Condition

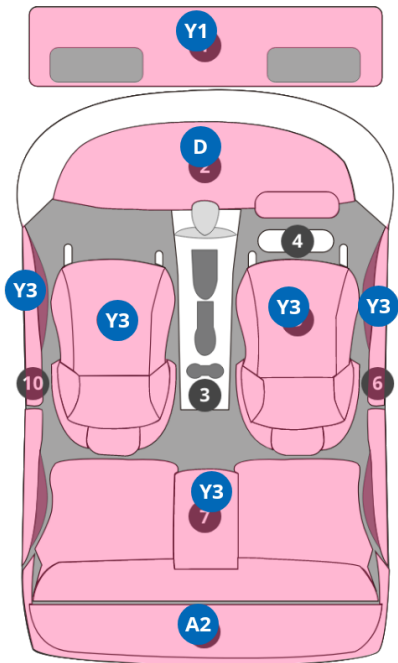
| Interior Evaluation : <b>C</b> | Exterior Evaluation : <b>D</b> |
| <p><b>Remarks</b></p> <p>Trunk Room - Worn, Scratch, Cut, Crack - Small / Rear Seat - Grime - Medium / (R) Front Seat - Grime - Medium / (R) Front Trim - Grime - Medium / (L) Front Trim - Grime - Medium / (L) Front Seat - Grime - Medium / Ceiling - Grime - Minimal / Dashboard - Traces of Adhesive Tape - Yes</p> | <p><b>Remarks</b></p> <p>(R) Rear Fender, Molding - Scratch - Medium / (R) Rear Door, Molding - Scratch - Small / (R) Mirror - Scratch - Small / (R) Front Door, Molding - Scratch - Small / (R) Front Fender, Molding - Scratch &amp; Dent - Medium / Front Bumper, Grille, Lamps - Scratch &amp; Dent - Medium / Bonnet, Headlight - Scratch - Small / (L) Mirror - Scratch - Minimal / (L) Rear Door, Molding - Scratch - Small / (L) Rear Fender, Molding - Scratch - Small / Trunk Hood, Rear Gate - Scratch &amp; Dent - Small / Rear Bumper, Lamps, Panels - Scratch - Small / Roof - Scratch &amp; Dent - Small / (L) Front Door, Molding - Scratch - Minimal</p> |
