## General Information

| Make | Toyota | Model | Vios |
| YOM | 2023 | Odo Meter Reading | 50,539 |

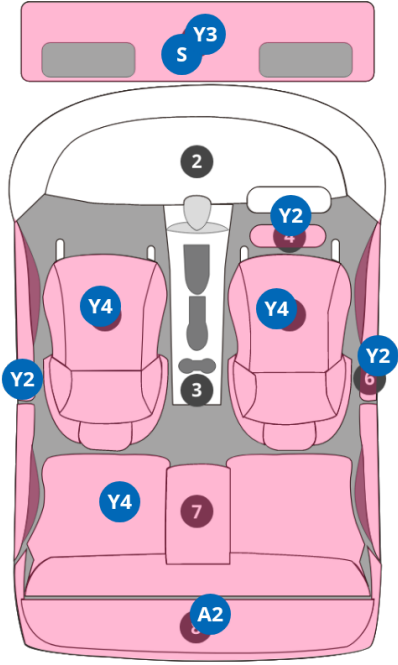
| Interior Evaluation : <b>C</b> | Exterior Evaluation : <b>E</b> |
| <p><b>Remarks</b></p> <p>Trunk Room - Worn, Scratch, Cut, Crack - Small / Overall Interior - Smell - Yes / Rear Seat - Grime - Large / Ceiling - Grime - Medium / (R) Front Seat - Grime - Large / (R) Front Trim - Grime - Small / Switches - Partially Missing - Yes / (L) Front Seat - Grime - Large / (L) Front Floor Mat - Grime - Small / (L) Front Trim - Grime - Small</p> | <p><b>Remarks</b></p> <p>Member (Bolted) - Dent - Yes / (R) Front Fender, Molding - Scratch &amp; Dent - Medium / (R) Front Door, Molding - Scratch &amp; Dent - Small / (R) Mirror - Scratch - Minimal / (R) Rear Door, Molding - Scratch - Medium / (R) Rear Fender, Molding - Scratch - Small / Rear Bumper, Lamps, Panels - Repair mark - Yes / Rear Bumper, Lamps, Panels - Scratch - Large / Trunk Hood, Rear Gate - Scratch - Medium / (L) Rear Fender, Molding - Scratch &amp; Dent - Small / (L) Rear Door, Molding - Scratch - Small / (L) Front Door, Molding - Dent - Small / (L) Mirror - Scratch - Small / (L) Front Fender, Molding - Scratch - Minimal / Front Bumper, Grille, Lamps - Scratch - Large / Bonnet, Headlight - Scratch &amp; Dent - Medium / Roof - Scratch &amp; Dent - Small</p> |

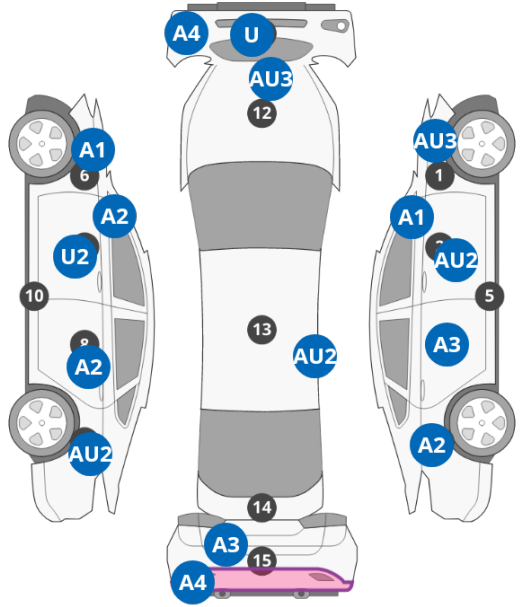
| Inspector Notes |
|---|
| with LTO plate, no warranty booklet, with jack and incomplete tools, with spare tire, scratches on headlight and tail light, trunk latch damaged |
