## General Information

| Make | Toyota | Model | Vios |
| YOM | 2024 | Mileage | 12,058 |

## Body / Panel Condition

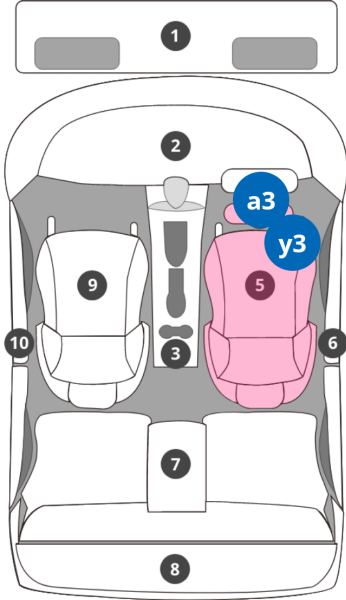
| Interior Evaluation : <b>B</b> | Exterior Evaluation : <b>C</b> |
| <b>Remarks</b><br>(L) Front Floor Mat - Cut, Crack - Medium / (R) Front Seat - Grime - Medium | <b>Remarks</b><br>(R) Step, In-panel, Side Spoiler - Scratch & Dent - Medium / (R) Rear Door, Molding - Scratch - Medium / Rear Bumper, Lamps, Panels - Scratch - Small / (L) Rear Fender, Molding - Scratch & Dent - Small / (L) Front Door, Molding - Scratch - Small / (L) Front Fender, Molding - Scratch - Medium / Front Bumper, Grille, Lamps - Scratch & Dent - Large / (R) Rear Fender, Molding - Scratch & Dent - Medium / Bonnet, Headlight - Scratch - Small |

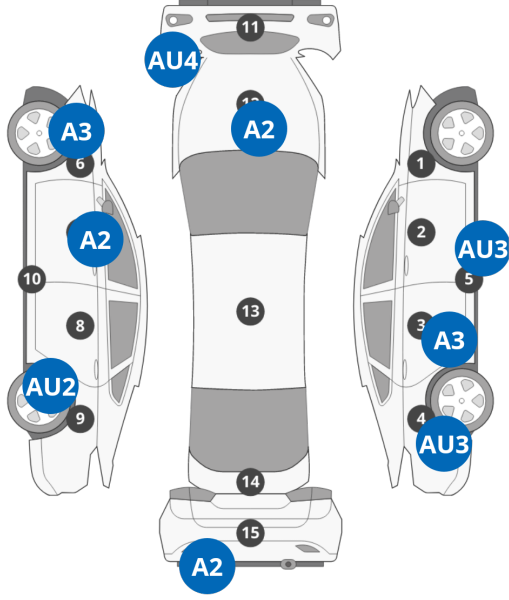
driver side mirror loose/ swirl marks and hairline scratches with spare tire, tools, and jack/ no warranty booklet
