## General Information

| Make | Toyota | Model | Vios |

## Body / Panel Condition

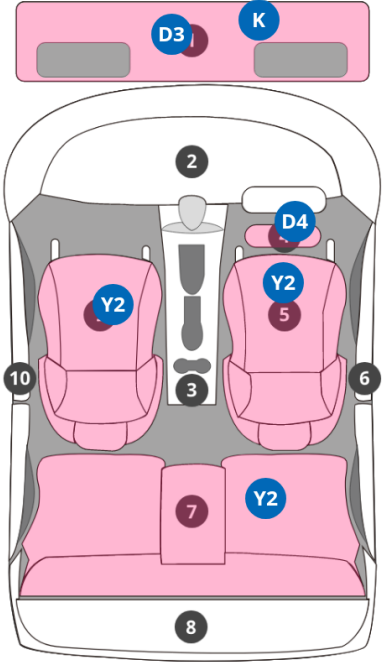
| Interior Evaluation : <b>C</b> | Exterior Evaluation : <b>E</b> |
|---|---|
| <p><b>Remarks</b></p> <p>Overall Interior - Animal Hair - Yes / (L) Front Floor Mat - Worked - Large / Ceiling - Crinkle - Medium / (R) Front Seat - Grime - Small / (L) Front Seat - Grime - Small / Rear Seat - Grime - Small</p> | <p><b>Remarks</b></p> <p>Trunk Hood, Rear Gate - Scratch &amp; Dent - Small / (L) Step, In-panel, Side Spoiler - Dent - Minimal / (L) Front Tyre - Crack, Cut - Yes / (L) Front Door, Molding - Scratch &amp; Dent - Small / (L) Rear Door, Molding - Scratch - Small / (L) Front Fender, Molding - Scratch - Small / (L) Mirror - Scratch - Minimal / Member (Bolted) - Dent - Yes / Front Bumper, Grille, Lamps - Scratch - Medium / (R) Step, In-panel, Side Spoiler - Dent - Small / (R) Front Door, Molding - Scratch - Small / (R) Front Fender, Molding - Scratch - Small / (R) Rear Door, Molding - Scratch &amp; Dent - Small / (R) Rear Fender, Molding - Scratch - Small / Rear Bumper, Lamps, Panels - Scratch - Medium / (L) Rear Fender, Molding - Scratch - Minimal / Roof - Scratch &amp; Dent - Medium</p> |
