## General Information

| Make | Toyota | Model | Vios |
| Registration No. | CBE5284 | Chassis No. | PA1B18F34N4168841 |

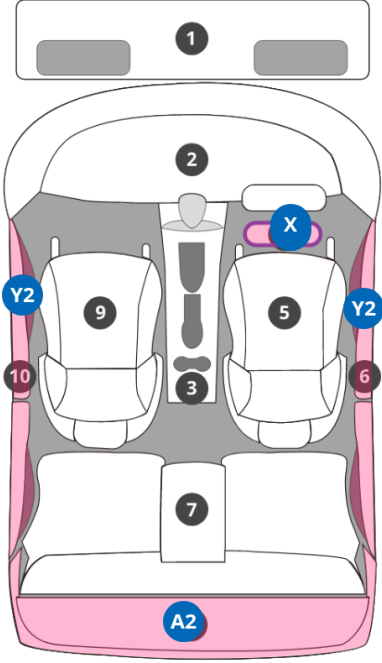
| <b>Interior Evaluation :</b> <b>B</b> | <b>Exterior Evaluation :</b> <b>B</b> |
| <b>Remarks</b><br>(L) Front Floor Mat - Missing - Yes / (R) Front Floor Mat - Missing - Yes / (R) Front Trim - Grime - Small / (L) Front Trim - Grime - Small / Trunk Room - Worn, Scratch, Cut, Crack - Small | <b>Remarks</b><br>Front Bumper, Grille, Lamps - Scratch - Medium / (R) Front Door, Molding - Scratch - Minimal / Rear Bumper, Lamps, Panels - Scratch - Small |
