## General Information

| Make | Toyota | Model | Wigo |
| Registration No. | CBD9080 | Chassis No. | MHKA4DF5FNJ070810 |

## Body / Panel Condition

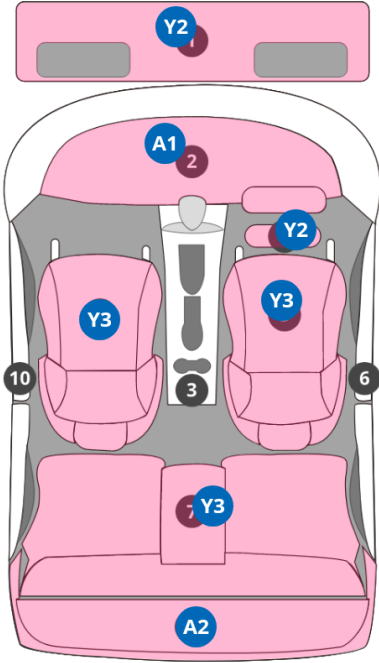
| Interior Evaluation : <span style="color: red;">C</span> | Exterior Evaluation : <span style="color: red;">C</span> |
| <p><b>Remarks</b></p> <p>(R) Front Seat - Grime - Medium / Rear Seat - Grime - Medium / Trunk Room - Worn, Scratch, Cut, Crack - Small / Dashboard - Worn, Scratch, Cut, Crack - Minimal / (L) Front Seat - Grime - Medium / Ceiling - Grime - Small / (L) Front Floor Mat - Grime - Small</p> | <p><b>Remarks</b></p> <p>(R) Front Door - Repair Traces - Yes / (R) Front Fender - Repair Traces - Yes / Bonnet - Repair Traces - Yes / (L) Front Fender - Repair Traces - Yes / (L) Front Door - Repair Traces - Yes / (L) Rear Door - Repair Traces - Yes / (L) Rear Fender - Repair Traces - Yes / Trunk Hood, Rear Gate - Repair Traces - Yes / (R) Rear Fender - Repair Traces - Yes / (R) Rear Door - Repair Traces - Yes / Roof - Repair Traces - Yes / (L) Front Fender, Molding - Repair mark - Yes / (L) Mirror - Crack - Damaged / Trunk Hood, Rear Gate - Scratch - Small / Rear Bumper, Lamps, Panels - Scratch - Small / (R) Rear Door, Molding - Scratch - Medium / (R) Front Door, Molding - Scratch - Small / (R) Mirror - Scratch - Minimal / (L) Front Fender, Molding - Scratch - Small / Front Bumper, Grille, Lamps - Scratch - Small / (R) Rear Fender, Molding - Scratch - Minimal / (L) Rear Door, Molding - Scratch - Minimal</p> |
