## General Information

| Make | Toyota | Model | Wigo |
| Registration No. | DAQ2548 | Chassis No. | MHKA4DF5FNJ066539 |

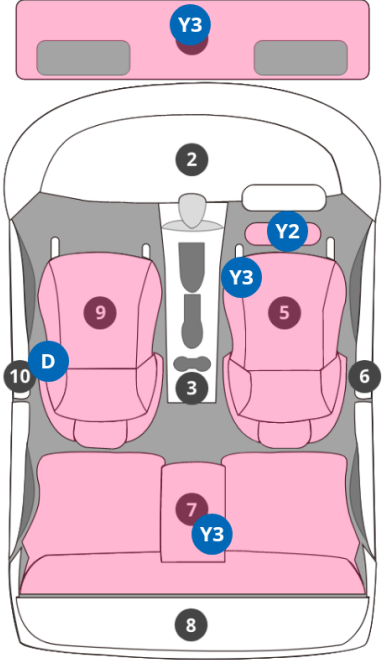
| Interior Evaluation : <b>C</b> | Exterior Evaluation : <b>D</b> |
|---|---|
| <p><b>Remarks</b></p> <p>Mat Other - Grime - Small / Rear Seat - Grime - Medium / (R) Front Seat - Grime - Medium / (L) Front Seat - Worn - Yes / Overall Interior - Worn as per age - Yes / Ceiling - Grime - Medium</p> | <p><b>Remarks</b></p> <p>(R) Front Fender, Molding - Scratch - Minimal / (R) Step, In-panel, Side Spoiler - Scratch &amp; Dent - Medium / (R) Rear Door, Molding - Scratch &amp; Dent - Large / (R) Rear Fender, Molding - Scratch &amp; Dent - Large / Rear Bumper, Lamps, Panels - Scratch - Small / Trunk Hood, Rear Gate - Scratch &amp; Dent - Minimal / (L) Rear Fender, Molding - Scratch - Minimal / (L) Rear Door, Molding - Dent - Minimal / (L) Front Door, Molding - Scratch &amp; Dent - Small / (L) Front Fender, Molding - Dent - Medium / Front Bumper, Grille, Lamps - Scratch &amp; Dent - Medium / Bonnet, Headlight - Scratch - Minimal / Roof - Dent - Small</p> |

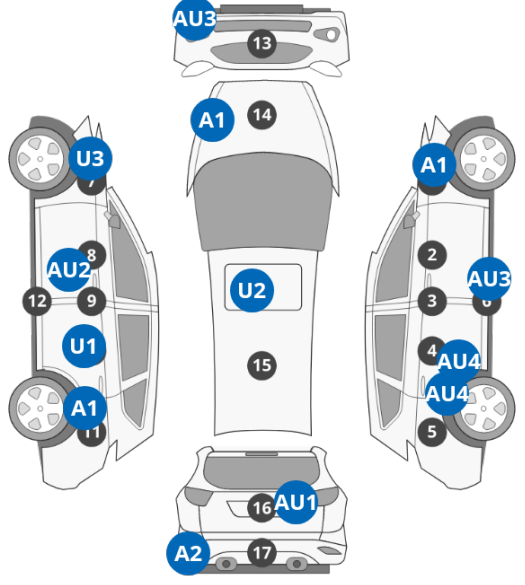
| Inspector Notes |
|---|
| no warranty booklet, with jack, no tools, with spare tire, with LTO plate, scratches on headlight and tail light, horn issue, damaged plate number |
