## General Information

| Make | Toyota | Model | Wigo |

## Overall Evaluation :

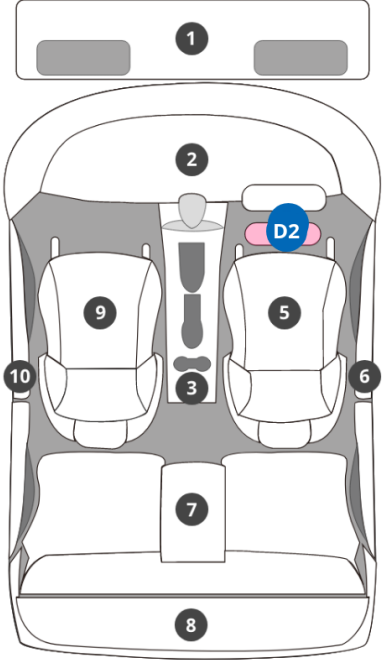
| <b>Remarks</b><br>(L) Front Floor Mat - Worked - Small / (R) Front Floor Mat - Worked - Small | <b>Remarks</b><br>(R) Mirror - Scratch - Minimal / (R) Front Door, Molding - Scratch - Minimal / (R) Rear Door, Molding - Scratch - Minimal / (R) Step, In-panel, Side Spoiler - Scratch - Small / (R) Rear Fender, Molding - Scratch & Dent - Minimal / Rear Bumper, Lamps, Panels - Scratch - Small / Trunk Hood, Rear Gate - Scratch & Dent - Small / (L) Rear Fender, Molding - Scratch - Minimal / (L) Rear Door, Molding - Scratch - Small / (L) Front Door, Molding - Scratch - Minimal / (L) Mirror - Scratch - Small / Front Bumper, Grille, Lamps - Scratch - Small / Bonnet, Headlight - Scratch - Small / Roof - Scratch - Minimal |
