## General Information

| Make | Toyota | Model | Wigo |

## Body / Panel Condition

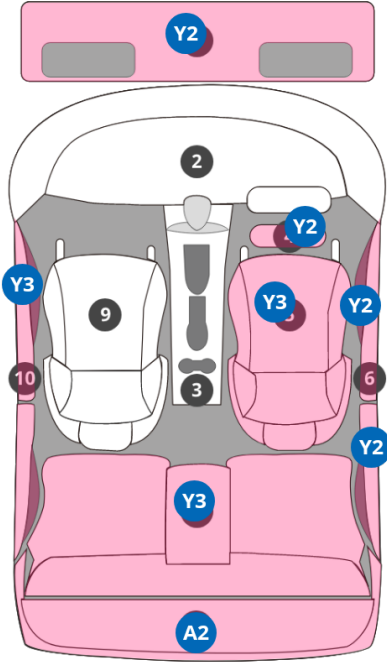
| Interior Evaluation : <span style="color: red;">C</span> | Exterior Evaluation : <span style="color: red;">E</span> |
|---|---|
| <b>Remarks</b><br>(R) Front Seat - Grime - Medium / (R) Front Trim - Grime - Small / Rear Seat - Grime - Medium / (R) Rear Trim - Grime - Small / Trunk Room - Worn, Scratch, Cut, Crack - Small / (L) Front Floor Mat - Grime - Small / Ceiling - Grime - Small / (L) Front Trim - Grime - Medium | <b>Remarks</b><br>(R) Front Fender - Repair Traces - Yes / (L) Front Fender - Repair Traces - Yes / Trunk Hood, Rear Gate - Scratch & Dent - Medium / Rear Bumper, Lamps, Panels - Scratch & Dent - Large / (L) Rear Fender, Molding - Scratch - Small / (L) Rear Door, Molding - Scratch & Dent - Small / (L) Front Door, Molding - Scratch & Dent - Large / (L) Front Fender, Molding - Crack, Gap - Medium / Bonnet, Headlight - Crack, Gap - Large / Front Bumper, Grille, Lamps - Scratch - Large / (R) Front Fender, Molding - Dent - Medium / (R) Rear Fender, Molding - Scratch & Dent - Small / (R) Rear Door, Molding - Scratch - Medium / (R) Front Door, Molding - Scratch - Small / (R) Mirror - Scratch - Small / Roof - Scratch - Medium / (L) Front Fender, Molding - Repair mark - Yes / (R) Front Fender, Molding - Repair mark - Yes / Rear Bumper, Lamps, Panels - Repair mark - Yes |
