## General Information

| Make | Toyota | Model | Wigo |

## Body / Panel Condition

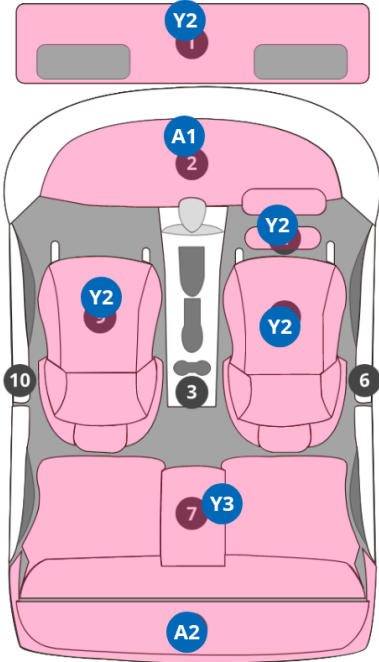
| Interior Evaluation : <b>B</b> | Exterior Evaluation : <b>D</b> |
| <b>Remarks</b><br>Trunk Room - Worn, Scratch, Cut, Crack - Small / Rear Seat - Grime - Medium / (R) Front Seat - Grime - Small / (R) Front Floor Mat - Grime - Small / (L) Front Seat - Grime - Small / Ceiling - Grime - Small / Dashboard - Worn, Scratch, Cut, Crack - Minimal | <b>Remarks</b><br>(R) Mirror - Crack - Damaged / Front Bumper, Grille, Lamps - Scratch - Large / (R) Front Fender, Molding - Dent - Small / (L) Front Door, Molding - Scratch - Small / (R) Rear Fender, Molding - Scratch - Small / Rear Bumper, Lamps, Panels - Scratch & Dent - Medium / (R) Front Door, Molding - Scratch - Medium / (R) Rear Door, Molding - Scratch - Small / (L) Rear Fender, Molding - Scratch - Minimal / Roof - Dent - Small / (L) Front Fender, Molding - Scratch - Small |

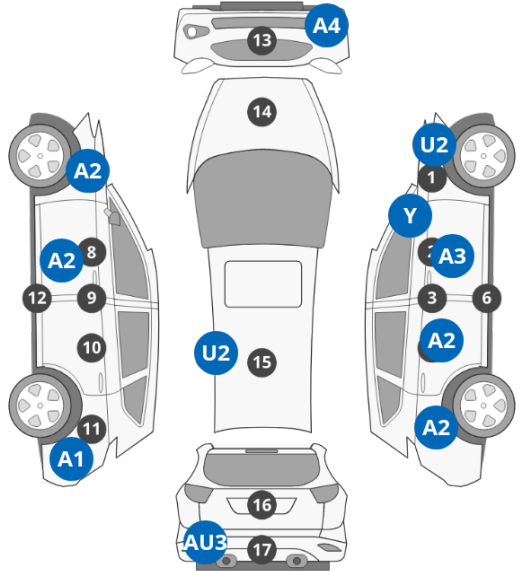
| Inspector Notes |
|---|
| with LTO plate/with spare tire/No jack and tools/with warranty booklet/right side mirror issue/right side front bumper small cover missing/trunk spare tire cover issue |
