## General Information

| Make | Toyota | Model | Vios |
| YOM | 2021 | Odo Meter Reading | 65,882 |
| Registration No. | DBF2638 | Chassis No. | PA1B18F37M4155315 |

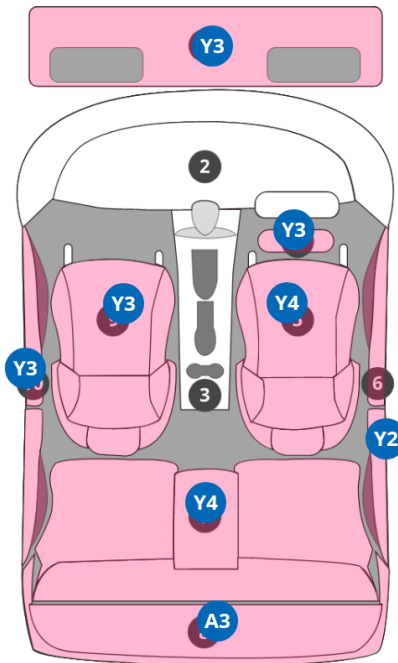
| Interior Evaluation : <span style="color: red;">D</span> | Exterior Evaluation : <span style="color: red;">E</span> |
| <b>Remarks</b><br>Trunk Room - Worn, Scratch, Cut, Crack - Medium /<br>Rear Seat - Grime - Large / Mat Other - Grime -<br>Medium / (R) Rear Trim - Grime - Small / (R) Front Seat<br>- Grime - Large / (L) Front Seat - Grime - Medium / (L)<br>Front Trim - Grime - Medium / Ceiling - Grime -<br>Medium / Overall Interior - Worn as per age - Yes | <b>Remarks</b><br>(R) Front Door - Repair Traces - Yes / (R) Front Fender - Repair Traces - Yes / Bonnet - Repair<br>Traces - Yes / (L) Front Fender - Repair Traces - Yes / (L) Front Door - Repair Traces - Yes /<br>Trunk Hood, Rear Gate - Repair Traces - Yes / (R) Rear Fender - Repair Traces - Yes / (R) Rear<br>Door - Repair Traces - Yes / Roof - Repair Traces - Yes / (R) Front Door, Molding - Repair<br>mark - Yes / (R) Front Fender, Molding - Repair mark - Yes / Bonnet, Headlight - Repair mark<br>- Yes / (L) Front Fender, Molding - Repair mark - Yes / (L) Front Door, Molding - Repair mark -<br>Yes / Trunk Hood, Rear Gate - Repair mark - Yes / (R) Rear Fender, Molding - Repair mark -<br>Yes / (R) Rear Door, Molding - Repair mark - Yes / Roof - Repair mark - Yes / (R) Front<br>Fender, Molding - Scratch - Medium / (R) Mirror - Scratch - Small / (R) Front Door, Molding -<br>Scratch - Minimal / (R) Rear Door, Molding - Scratch & Dent - Medium / (R) Rear Fender,<br>Molding - Scratch & Dent - Small / Rear Bumper, Lamps, Panels - Repair mark - Yes / Rear<br>Bumper, Lamps, Panels - Scratch & Dent - Large / Trunk Hood, Rear Gate - Scratch & Dent -<br>Medium / (L) Rear Fender, Molding - Scratch - Small / (L) Rear Door, Molding - Scratch -<br>Medium / (L) Front Door, Molding - Scratch - Small / (L) Mirror - Scratch - Minimal / (L) Front<br>Fender, Molding - Dent - Minimal / Front Bumper, Grille, Lamps - Scratch & Dent - Large /<br>Roof - Dent - Small / Bonnet, Headlight - Rust, Corrosion - Small |
