## General Information

| Make | Toyota | Model | Wigo |
| Registration No. | NEW4079 | Chassis No. | MHKA4DF5FMJ056828 |

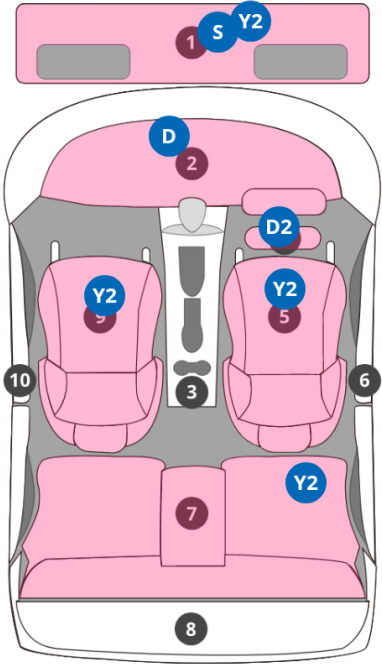
| <b>Interior Evaluation :</b> <b>B</b> | <b>Exterior Evaluation :</b> <b>E</b> |
| <b>Remarks</b><br>Rear Seat - Grime - Small / (R) Front Seat - Grime - Small / (L) Front Seat - Grime - Small / Ceiling - Grime - Small / Overall Interior - Smell - Yes / Dashboard - Traces of Adhesive Tape - Yes / (L) Front Floor Mat - Worked - Small | <b>Remarks</b><br>(R) Front Door - Repair Traces - Yes / (R) Front Fender - Repair Traces - Yes / Bonnet - Repair Traces - Yes / (L) Front Fender - Repair Traces - Yes / (L) Front Door - Repair Traces - Yes / (L) Rear Door - Repair Traces - Yes / (L) Rear Fender - Repair Traces - Yes / Trunk Hood, Rear Gate - Repair Traces - Yes / (R) Rear Fender - Repair Traces - Yes / (R) Rear Door - Repair Traces - Yes / Roof - Repair Traces - Yes / (R) Front Door, Molding - Repair mark - Yes / (R) Rear Door, Molding - Repair mark - Yes / (R) Rear Fender, Molding - Repair mark - Yes / (L) Rear Fender, Molding - Repair mark - Yes / (L) Front Door, Molding - Repair mark - Yes / (L) Front Fender, Molding - Repair mark - Yes / Bonnet, Headlight - Repair mark - Yes / (R) Front Fender, Molding - Repair mark - Yes / Roof - Repair mark - Yes / Trunk Hood, Rear Gate - Repair mark - Yes / (L) Rear Fender, Molding - Scratch & Dent - Small / Rear Bumper, Lamps, Panels - Crack, Gap - Medium / (R) Rear Fender, Molding - Scratch & Dent - Small / (R) Front Door, Molding - Scratch & Dent - Minimal / (R) Front Fender, Molding - Dent - Minimal / (R) Rear Door, Molding - Scratch - Small / Trunk Hood, Rear Gate - Scratch - Small / (L) Rear Door, Molding - Scratch - Small / (L) Front Door, Molding - Scratch - Small / (L) Mirror - Scratch - Small / (R) Mirror - Scratch - Small / (L) Front Fender, Molding - Scratch - Minimal / Front Bumper, Grille, Lamps - Rust, Corrosion - Medium / Roof - Scratch & Dent - Small / Bonnet, Headlight - Scratch & Dent - Small |

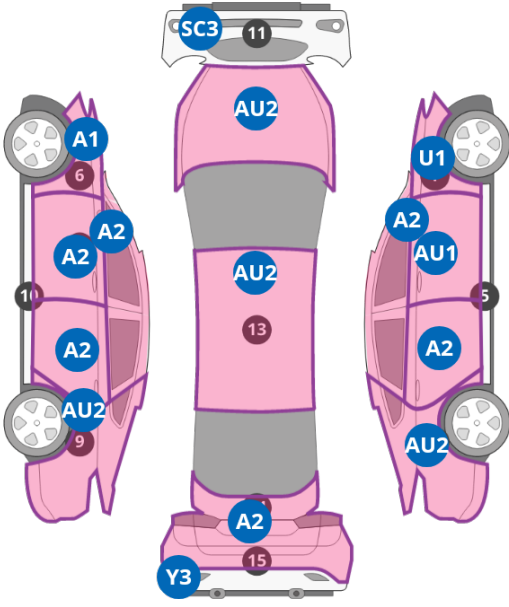
With warranty booklet and LTO Plate, Spare tire. scratch headlight and tail light, Crack right tail light, no Tools and Jack, check engine light on and airbag light indicator on.
