## General Information

| Make | Toyota | Model | Innova |
| Registration No. | NFC2663 | Chassis No. | PA2JA8EM6M0093415 |

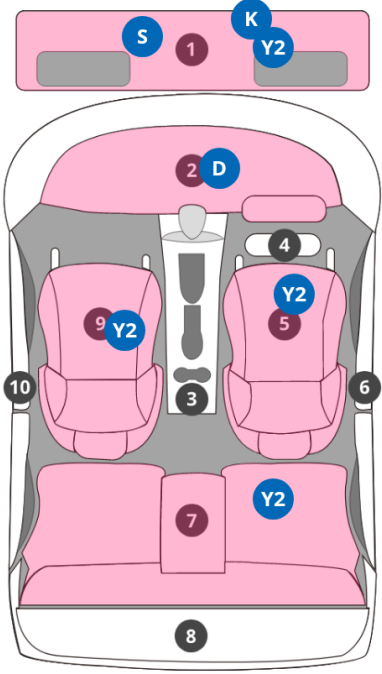
| <b>Interior Evaluation :</b> <b>B</b> | <b>Exterior Evaluation :</b> <b>D</b> |
| <b>Remarks</b><br>Overall Interior - Smell - Yes / (R) Front Seat - Grime - Small / (L) Front Seat - Grime - Small / Rear Seat - Grime - Small / Ceiling - Grime - Small / Overall Interior - Animal Hair - Yes / Dashboard - Traces of Adhesive Tape - Yes | <b>Remarks</b><br>(L) Rear Door - Repair Traces - Yes / (L) Rear Door, Molding - Repair mark - Yes / (L) Rear Door, Molding - Scratch - Small / (L) Front Door, Molding - Scratch - Small / (L) Step, In-panel, Side Spoiler - Scratch & Dent - Small / (L) Rear Fender, Molding - Scratch - Small / (L) Front Fender, Molding - Scratch - Minimal / Bonnet, Headlight - Scratch - Small / Member (Bolted) - Dent - Yes / Front Bumper, Grille, Lamps - Scratch - Medium / (R) Front Fender, Molding - Scratch - Small / (R) Front Door, Molding - Scratch - Small / (R) Rear Door, Molding - Scratch - Small / (R) Step, In-panel, Side Spoiler - Scratch & Dent - Small / (R) Rear Fender, Molding - Scratch & Dent - Medium / Rear Bumper, Lamps, Panels - Scratch - Small / (R) Mirror - Crack - Damaged |

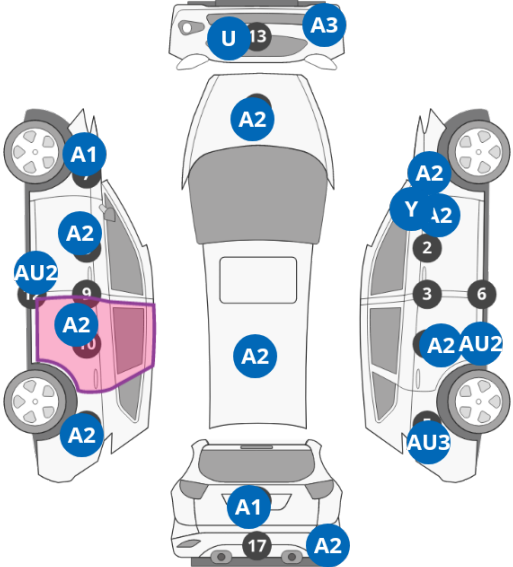
| With warranty booklet, Jack and Sparetire, Incomplete Tools. improvise LTO plate,no original LTO PLATE, right side mirror housing Crack, |
